# SOILS and ROCKS

An International Journal of Geotechnical and Geoenvironmental Engineering

**Abstract.** Many embankment dams completed during the first six decades of the 20th century have been found deficient relative their ability to resist currently anticipated levels of seismic shaking and probable maximum flood. In this Fourth Victor de Mello Lecture, two recent case histories are described. One is a hydraulic fill structure completed in 1920 that is founded on alluvial material, some zones of which are susceptible to liquefaction. The other is a zoned earthfill dam completed in 1956 that is founded over a channel filled with loose, uncompacted, hydraulically placed tailings from gold mining operations. Each dam has been upgraded in phases over periods of several decades using different strategies and ground improvement technologies to improve stability and reduce failure risks. Several take away lessons from these experiences concerning current risk mitigation strategies, the importance of correct soil and site characterization, and implementation and effectiveness of different ground stabilization and improvement methods are presented.

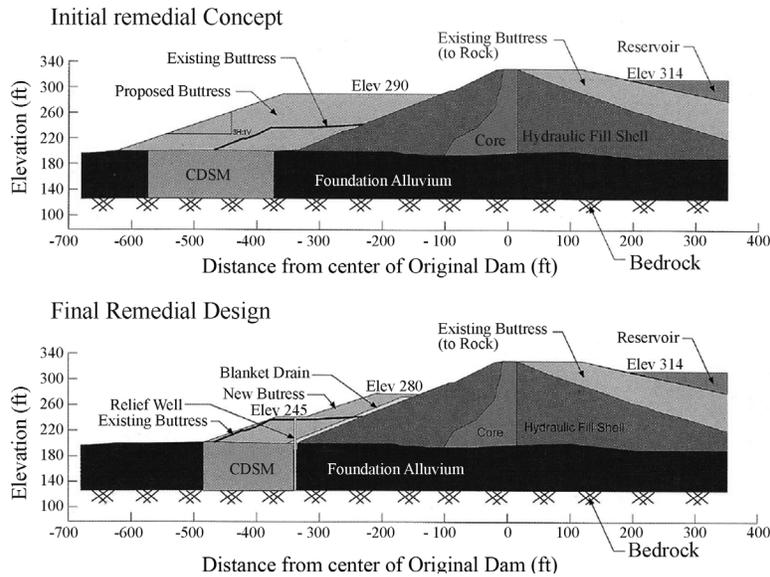
**Figure 3** - Remedial designs for mitigation of seismic risk to San Pablo Dam (from Yiadom & Roussel, 2012).

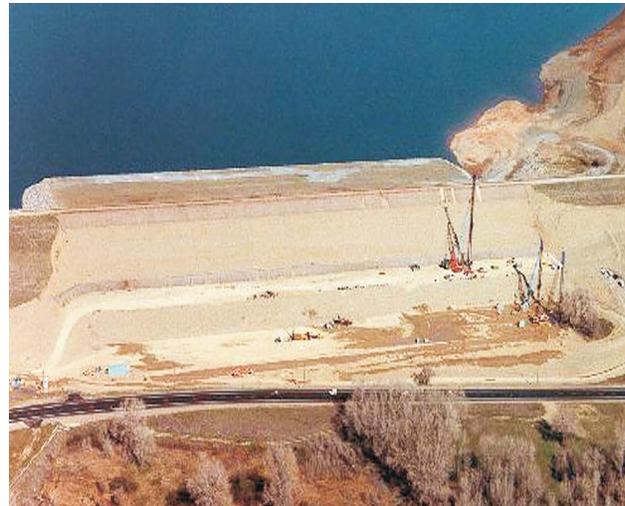
**Figure 13** - Installation of stone columns and gravel mini-column drains beneath the downstream embankment of Mormon Island Auxiliary Dam in 1994. Note the excavation and steepened slope needed for development of a working platform and for optimization of the improvement zone location for its effectiveness as a key block.

900 ft (275 m) long by 200 ft (61 m) wide in plan, in the area labeled “Downstream improvement” in Fig. 7. Excavation into the existing downstream embankment was required in order to develop a level working platform, Fig. 13, for installation of 1.2 m (4 ft) diameter wet, bottom feed, vibro-replacement stone columns and the upstream and downstream drainage zones that are composed of 250 mm diameter gravel columns on 1.0 m centers installed using a vibro-pipe. It is important to note that excavation into the downstream slopes of embankment dams is not without risk owing to reduced seepage paths and lower factors of safety against stability failure while the excavation is open, both of which must be accounted for in assessing risk during construction.

It is imperative to keep in mind, however, that whenever a project involves excavation into the downstream slope; e.g., during the stone column and drain installation, Fig. 13, or into the foundation, as was necessary for the key block construction at MIAD, Fig.16, there may be increased seepage as well as a temporary decrease in factor of safety against stability failure while the excavation is open that must be evaluated and assessed in terms of increased failure risk.

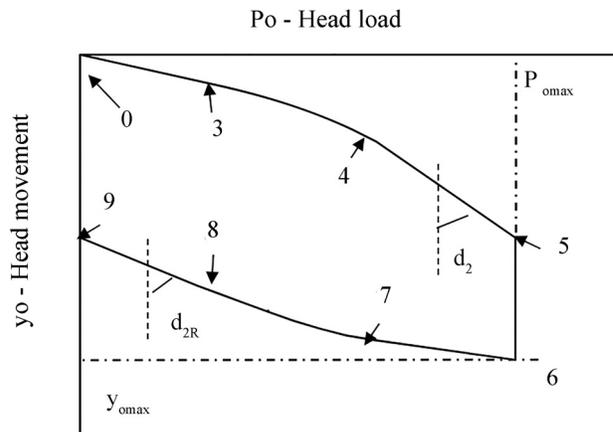
Figure 6 - Theoretical Load-movement curve.

Note: The suffixes "R" and "reb" refer to the rebound condition (see Fig. 5 and 6).

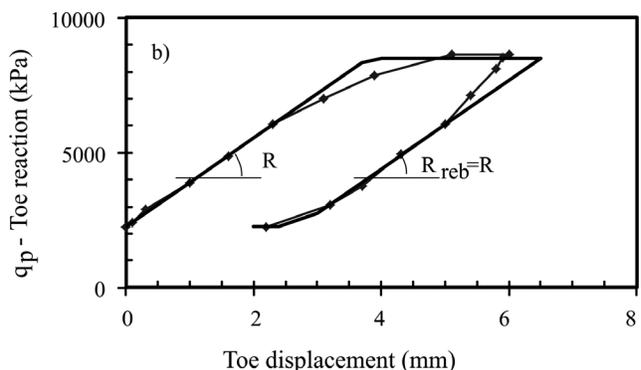
Figure 10 - Van Weele's pile:  $f$  and  $q_p$  caused by loading up to 1500 kN and unloading.

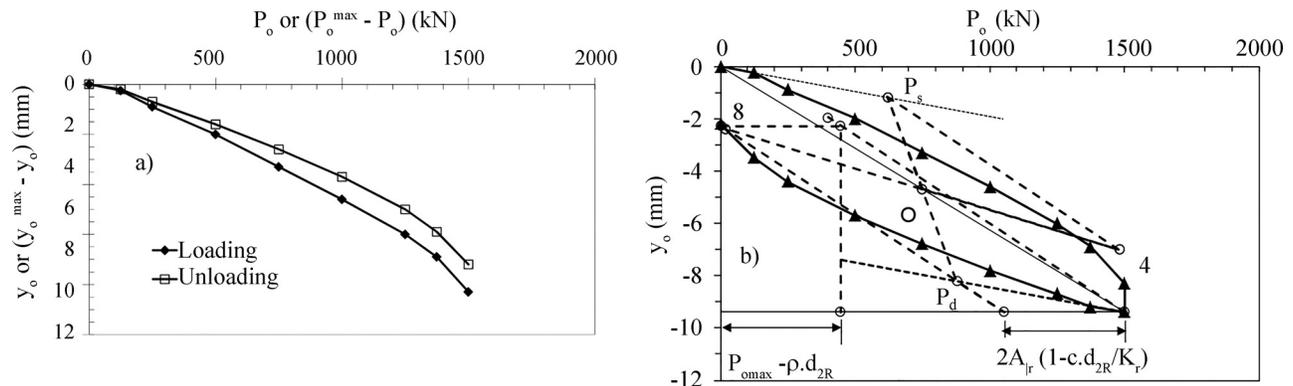
**Figure 11** - Van Weele's Pile: load-movement curves, loading up to 1500 kN and unloading.

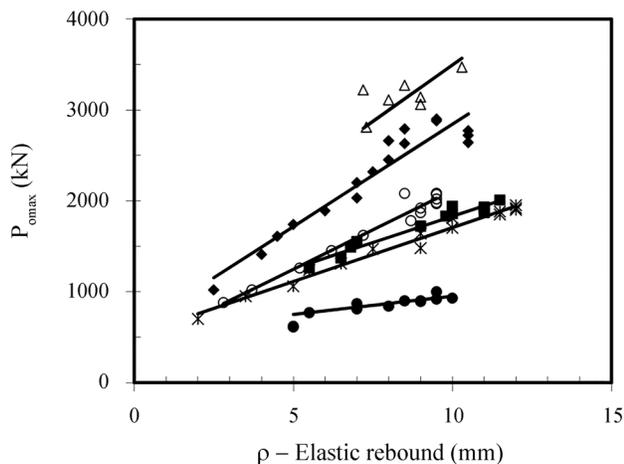
Figure 12 - Van Weele's Equation for piles of Group I.

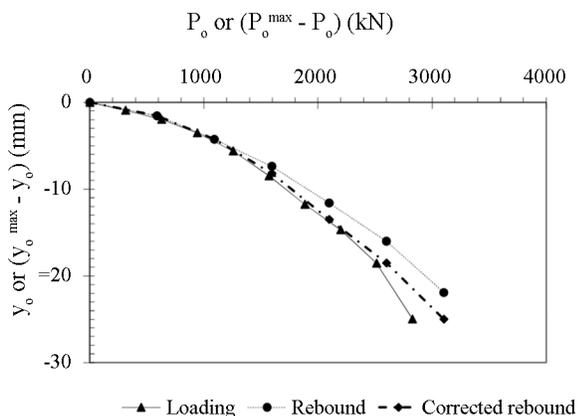
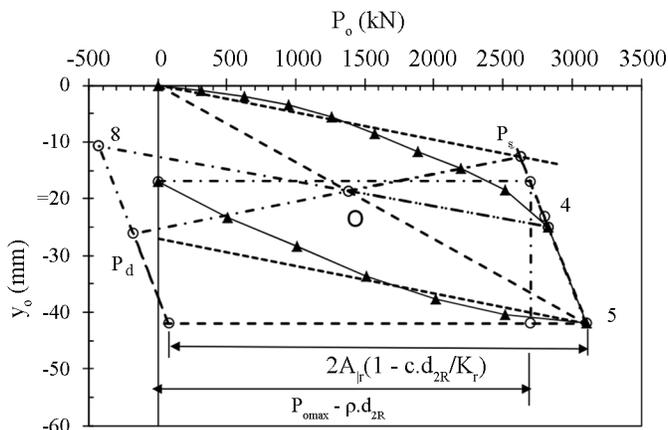
Figure 23 - Pile Alamoia 13– Group II. Static loading tests.

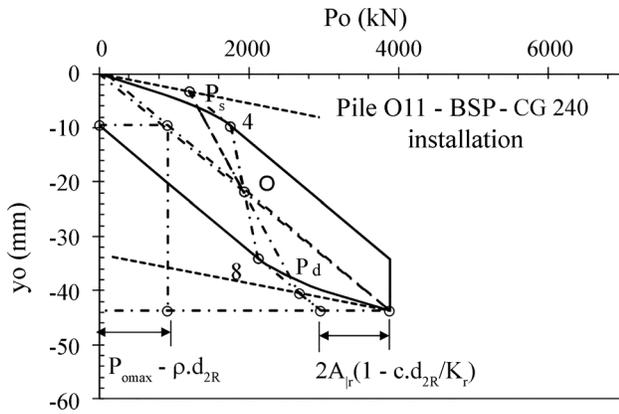
Figure 29 - Dynamic loading test.

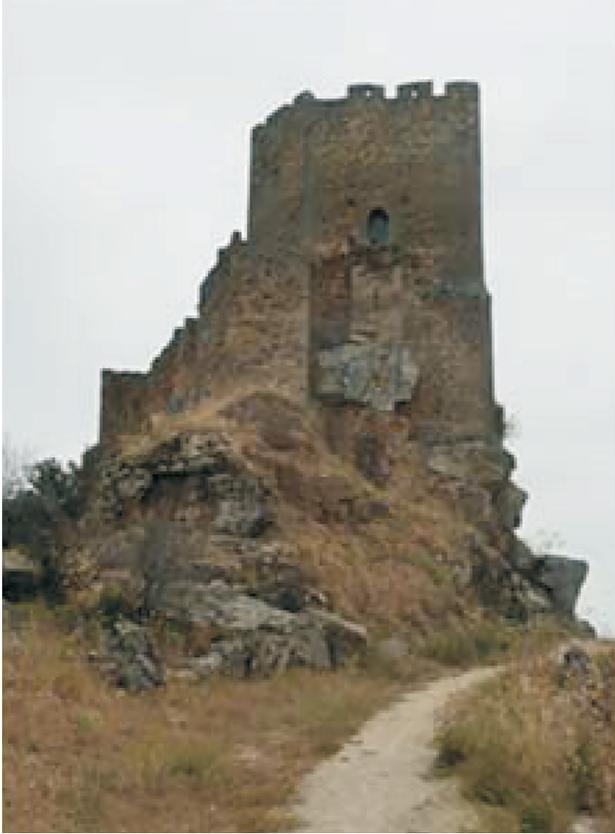
**Figure 1** - Foundations of the medieval Algozo Fort.

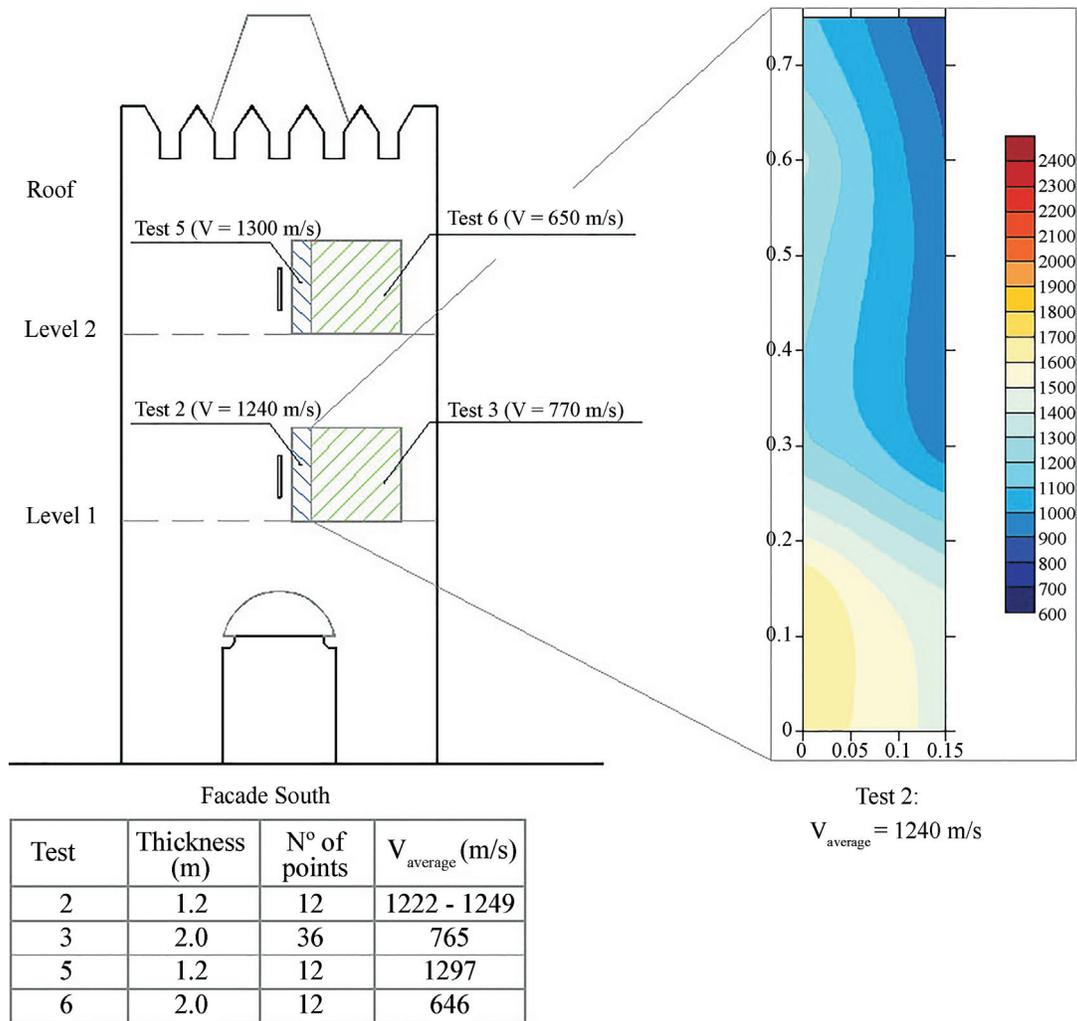
**Figure 8** - Results of a sonic test for the walls of Caminha tower (Silva *et al.*, 2009).

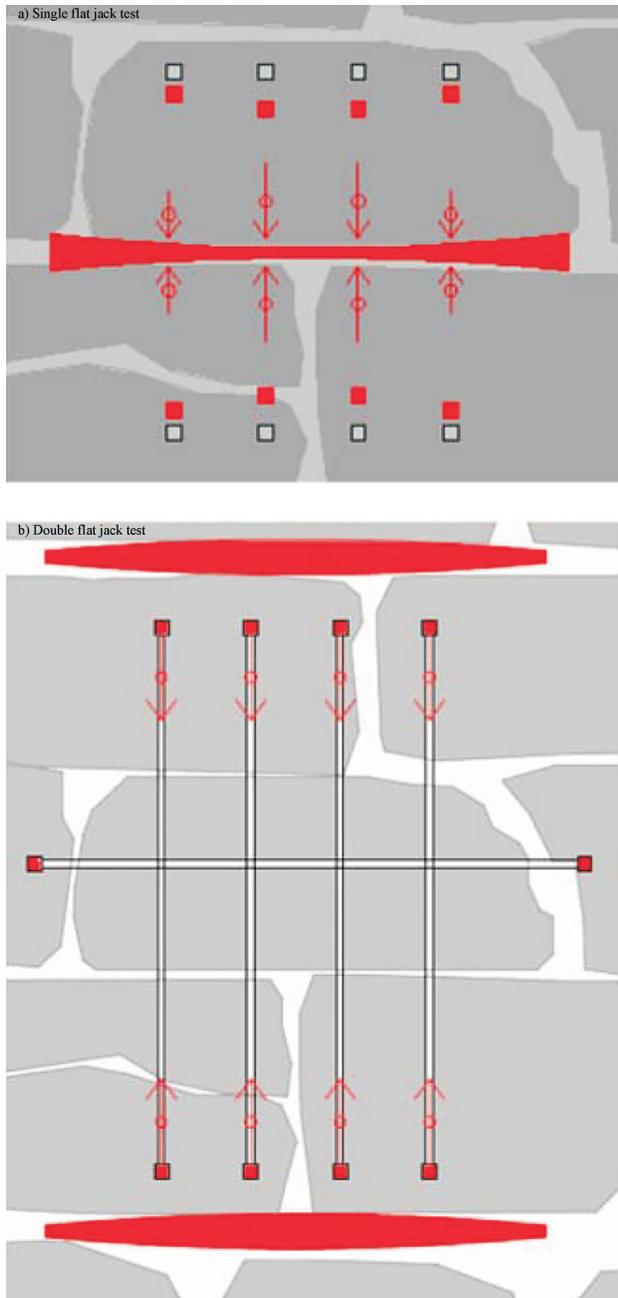
**Figure 9** - Type of flat jack tests: single and double test (Miranda *et al.*, 2010). a) Single flat jack test. b) Double flat jack test.

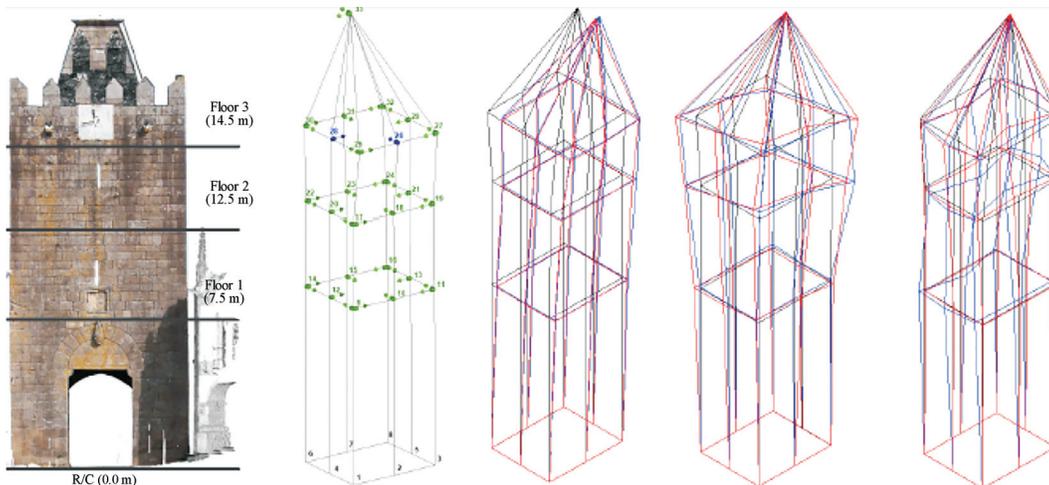
**Figure 13** - Mode shapes identified from dynamic tests on Caminha tower (Lopes *et al.*, 2010).

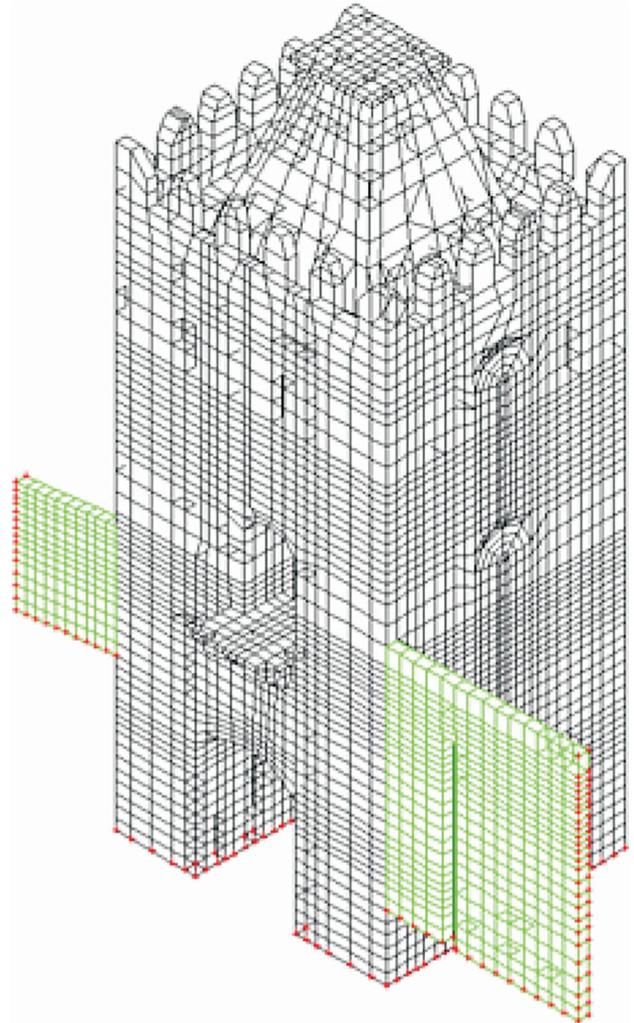
**Figure 16** - Numerical discretization of Caminha tower using volume elements (Lopes *et al.*, 2010).

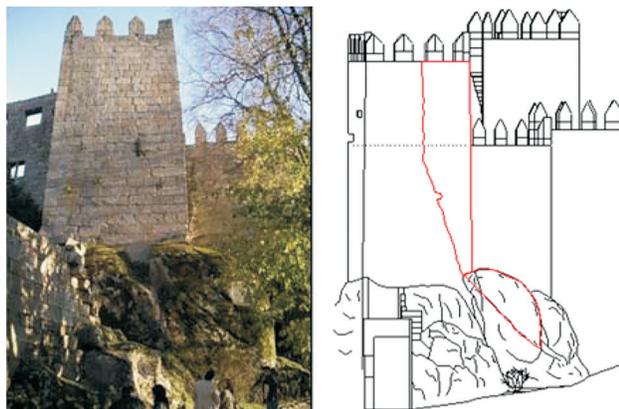
Figure 18 - Perspective of the instabilized foundations.

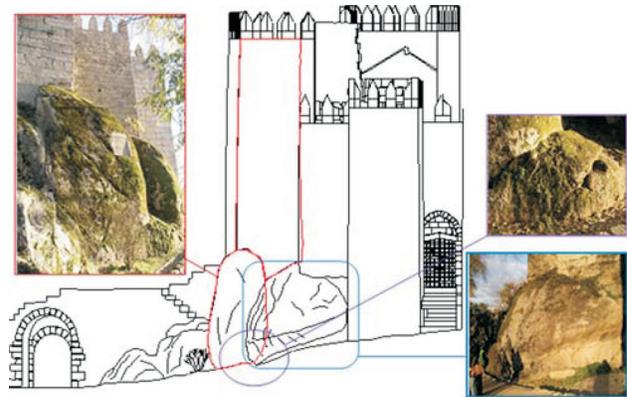
Figure 19 - Perspective of the granite massif that supports the foundation of the tower.

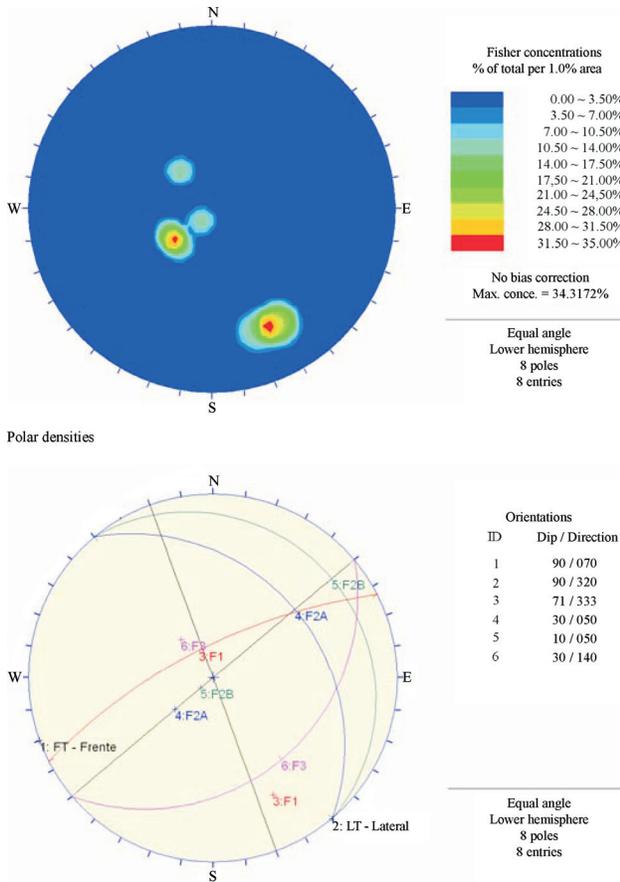
**Figure 20** - General aspects of the discontinuities (Mota Engil, 2009).

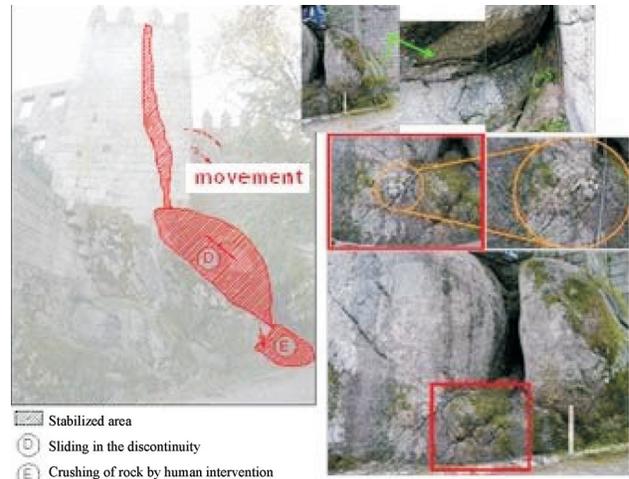
**Figure 21** - Instability mechanism explaining the observed damage.

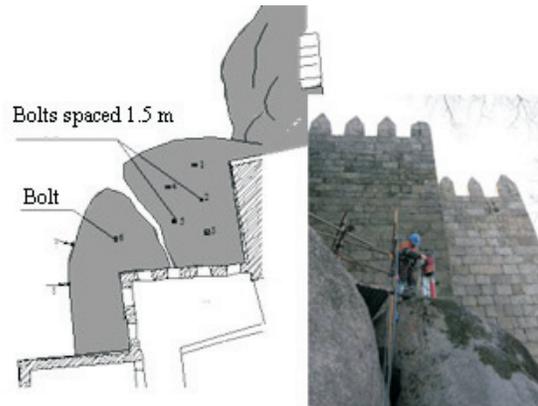
**Figure 22** - Plan of nailing positioning and drilling.

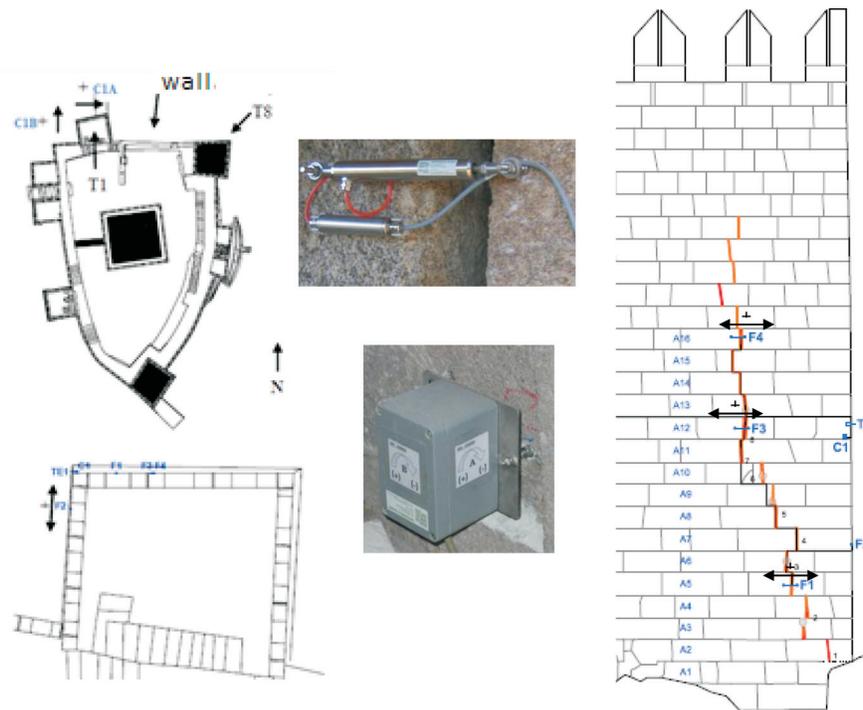
**Figure 23** - Guairães Castle. Instrumentation on tower T1 for structural monitoring with relative displacement (crackmeter) and rotation monitoring (tiltmeter) (Arêde *et al.*, 2010).

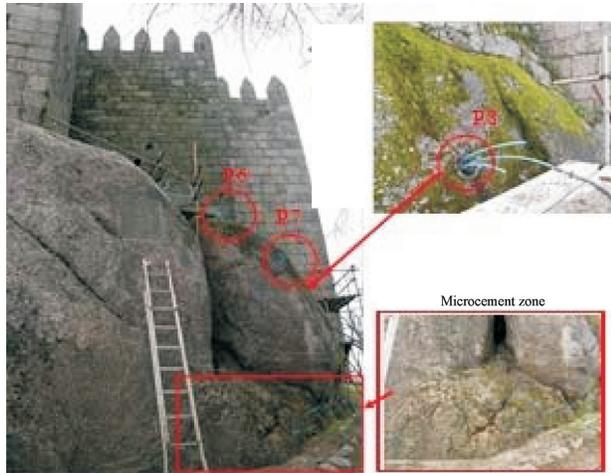
**Figure 24** - Arrangement of nailings and consolidation zone with micro-cement.

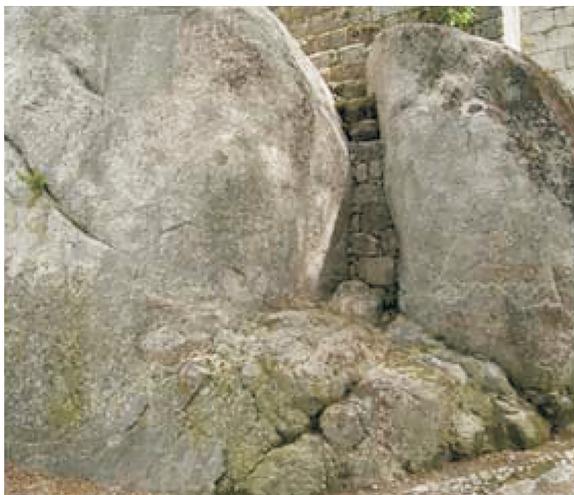
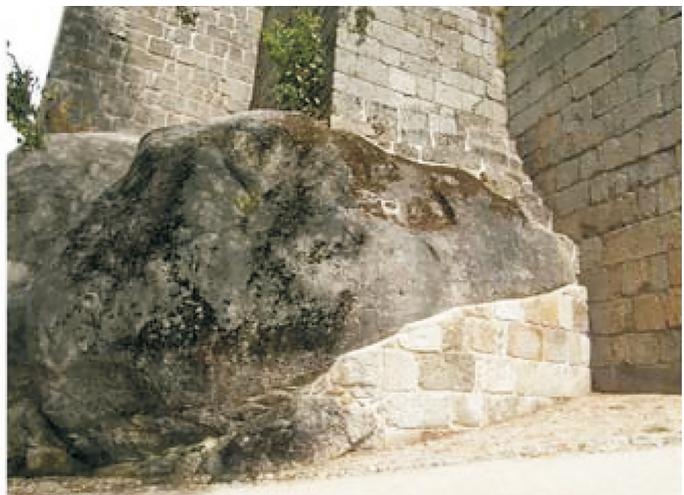
**Figure 25** - Stabilized situation of the castle.

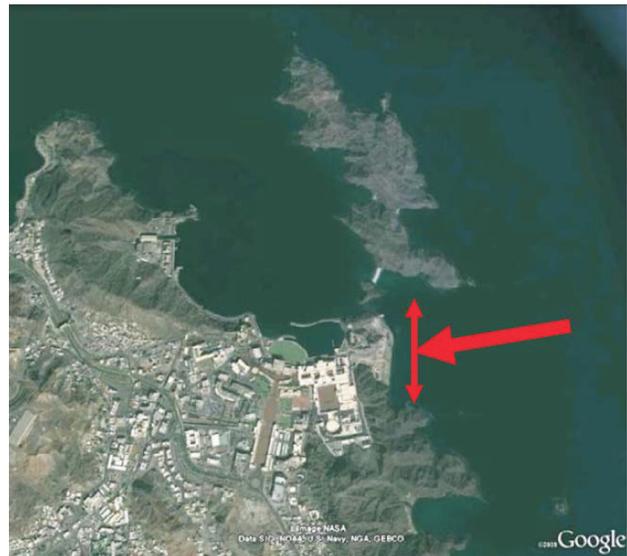
**Figure 30** - Jalali Fort. Location of the new seawall.

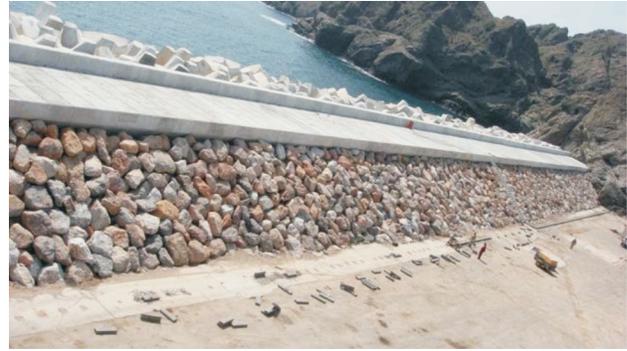
**Figure 33** - View of the new protection of Jalali Fort.

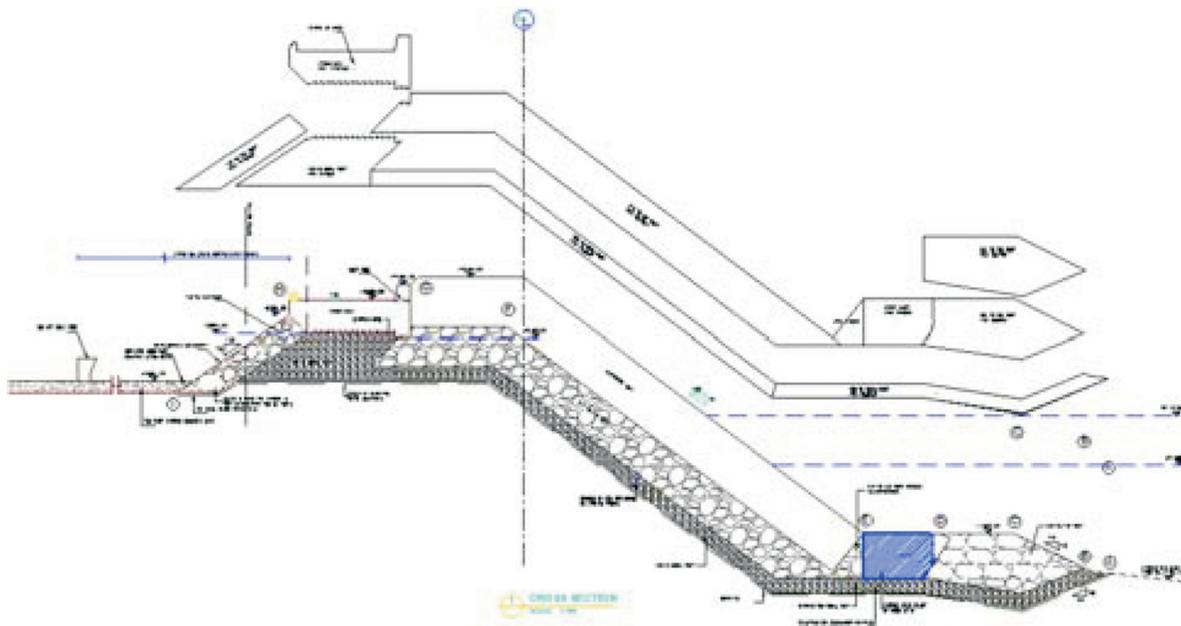
**Figure 32** - Final design typical section.

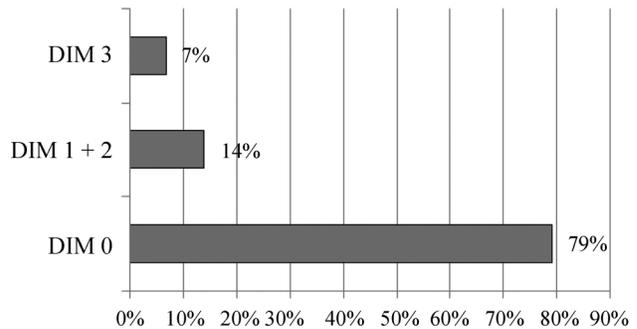
Figure 3 - Morphological classification of the pre-treated waste material.

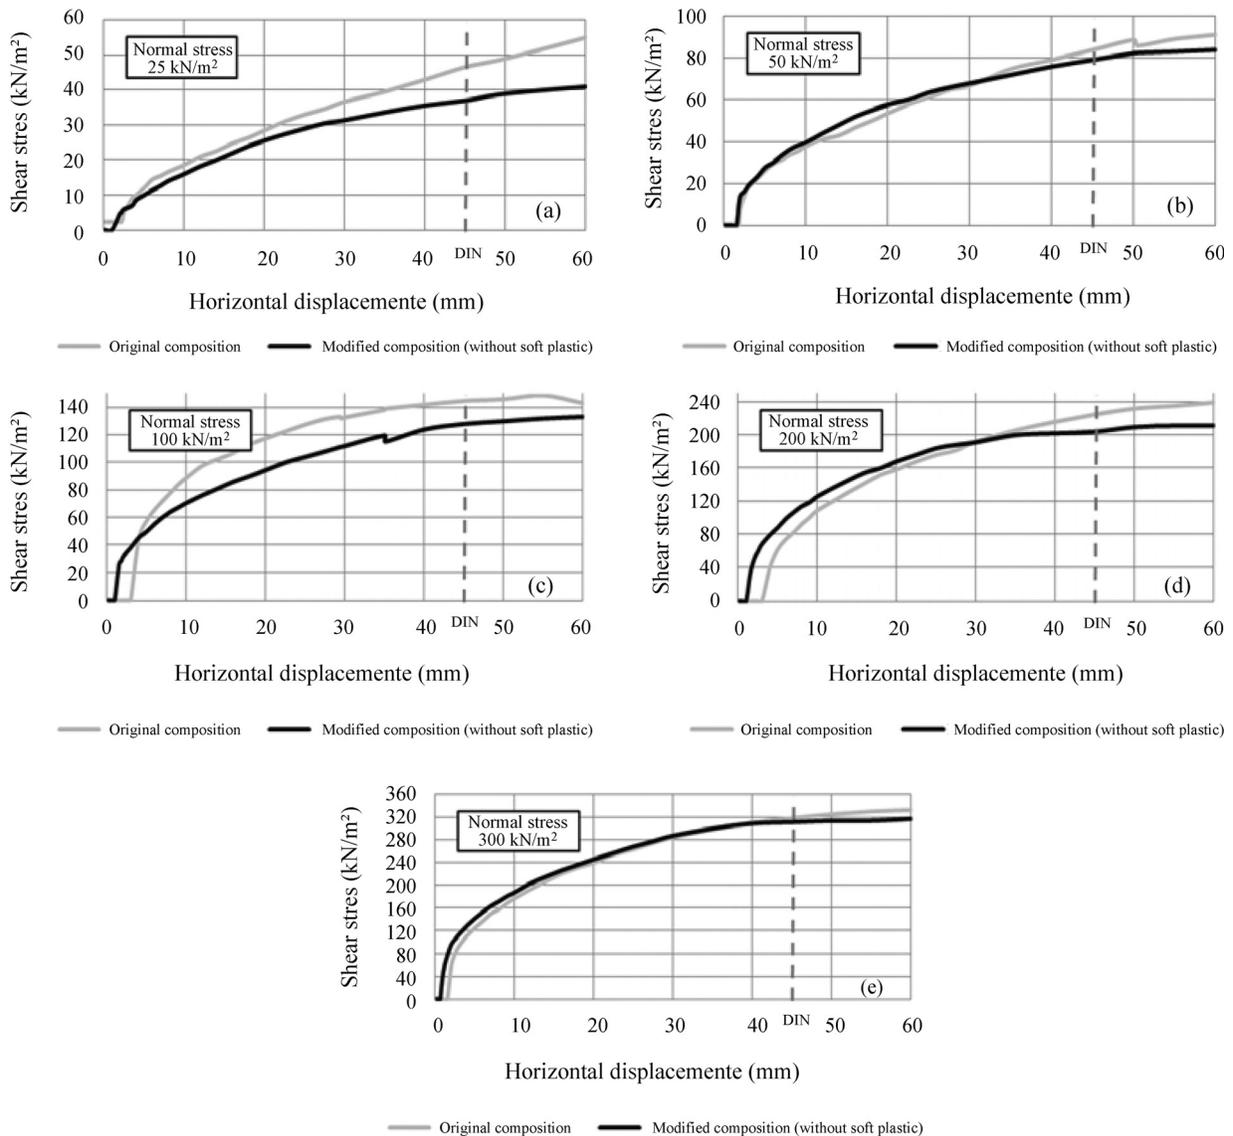
**Figure 6** - Shear strength vs. horizontal displacement curves for pre-treated waste material.

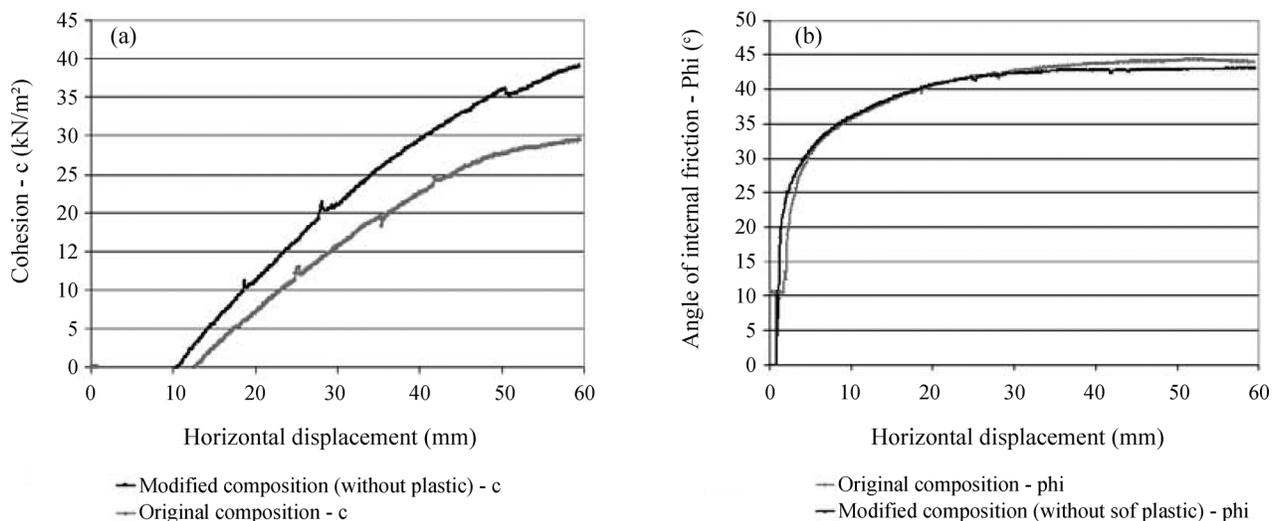
**Figure 7** - Mobilisation of shear strength parameters of pre-treated waste material.

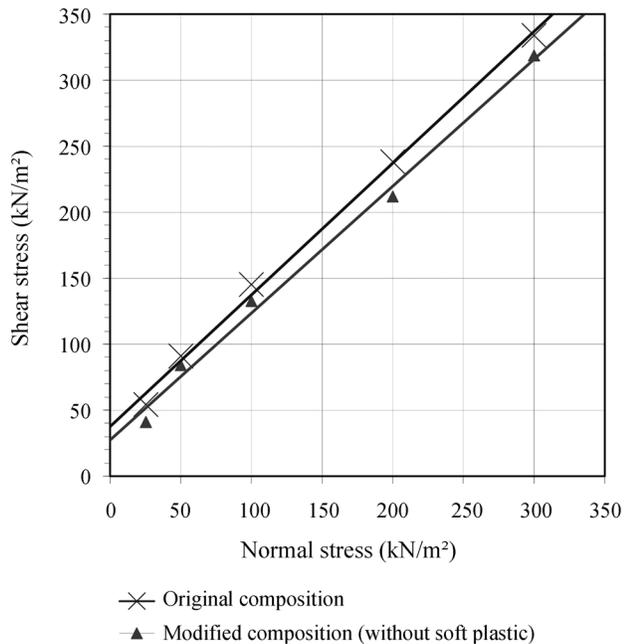
**Figure 8** - Shear strength envelopes (Mohr-Coulomb) for the pre-treated waste material considering DIN 18137-3 (2002).

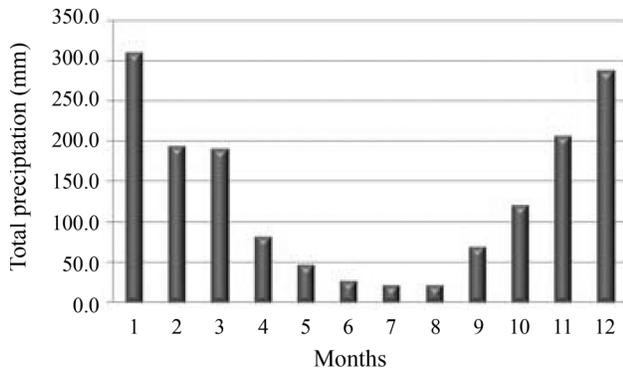
**Figure 2** - Average total precipitation at Coronel Pacheco station, located 30 km from Tabuleiro cemetery.

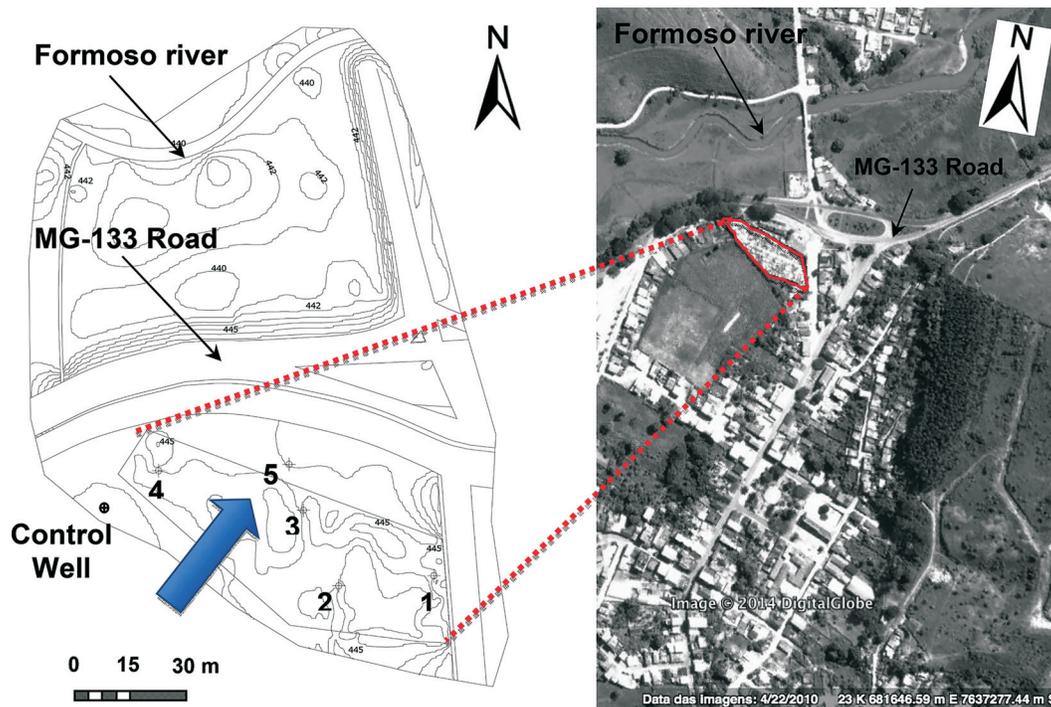
**Figure 3** - On the left, the topography of the cemetery area (within straight lines on the South of the road) and its vicinities, and location of the monitoring wells, Tabuleiro-MG, Brazil. Blue dart show the groundwater flow direction. On the right, a satellite image (Google Earth, 2014) showing the cemetery (limit in red) and its vicinity.
