# Mapping of Geological-Geotechnical Risk of Mass Movement in an Urban Area in Rio Piracicaba, MG, Brazil

L.E. Assis, E.A.G. Marques, C.A. Lima, S.J.M.C. Menezes, L.A. Roque

**Abstract.** The objective of this study is to create a geological-geotechnical risk map of mass movement for an urban perimeter of Rio Piracicaba city, state of Minas Gerais, MG, Brazil, by applying the methodology proposed by the Brazilian Ministry of Cities. Four neighborhoods were evaluated through works conducted in the field and with the aid of a GIS fed with aerial images obtained from an Unmanned Aerial Vehicle (UAV). In these neighborhoods, 29 points were categorized as risk-points, and 14 risk areas were delimited and hierarchized. Despite being considered a subjective evaluation, the methodology used is a simple and efficient qualitative method, which can contribute significantly to the preliminary identification of areas under risk of mass movements, indicating the nature of the predisposing factors. The areas classified as high-risk present significant physical and environmental problems, mainly due to non-compliance with current legislation regarding urban planning and land use. The outcomes of

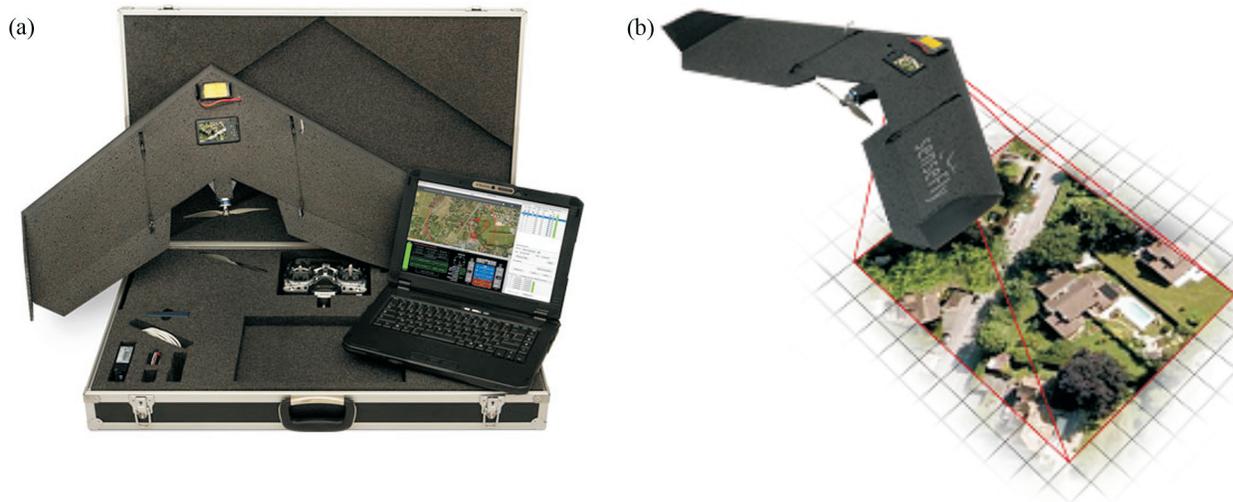
Figure 2 - UAV - Swinglet Cam Sensefly (Santiago & Cintra, 2015).

A Sensefly Swinglet CAM Unmanned Aerial Vehicle (UAV) was used to survey the study area (Fig. 2). The UAV features a calibrated 12 MP Canon IXUS220HS RGB on-board camera that allows 7 to 30 cm/pixel spatial resolution (GSD) images. Its navigation system has sensors and GPS receivers with flight autonomy of up to 30 min and it is able to fly at a cruising speed of up to 36 km/h and resistance to winds of 5 m/s<sup>1</sup>.

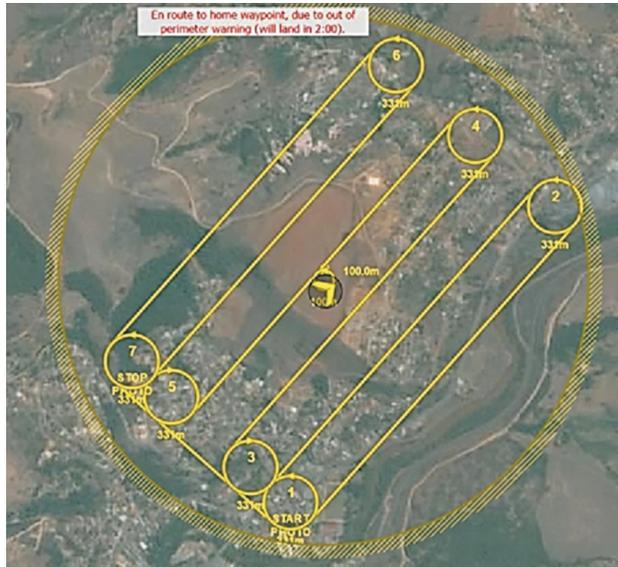
**Figure 3** - Flight plan elaborated for the aerophotogrammetry of the study area. (Geographic Coordinate: Latitude: 691744,632; Longitude: 7796284,803).

A Garmin 60CSx GPS, with positioning accuracy ≤ 10.0 m, was used to collect the points. The takeoff area of the UAV was set at Point 1, from where the flight plan was executed (Fig. 3). The eMotion 2 software was used to control the UAV; it allows telemetry connection to the computer and transmits frequent correction signals, besides

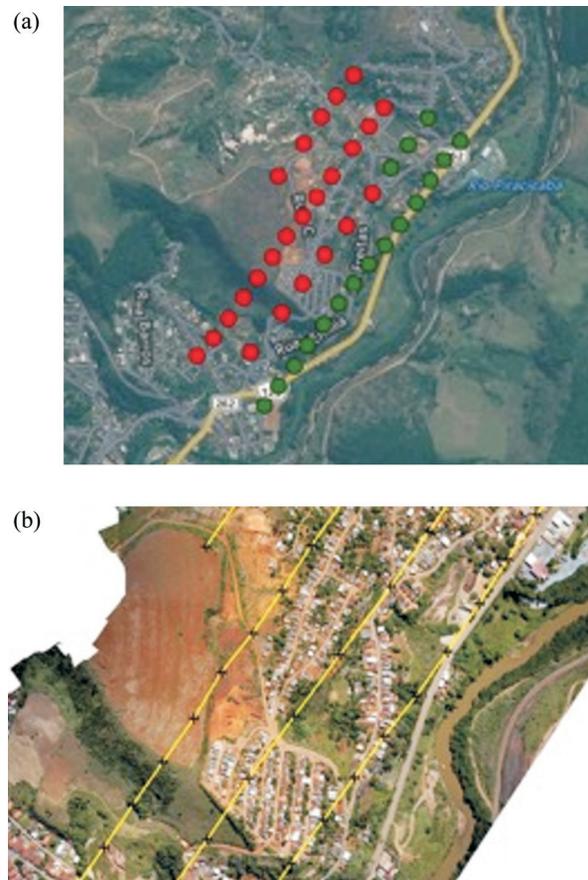
**Figure 4** - (a) Element of Pix4UAV® Desktop Software in the study area after taking pictures (Geographic Coordinate: Latitude: 691744,632; Longitude: 7796284,803). (b) Component part of the processed Orthophoto showing the flight paths (trajectory) of the UAV over the studied area (Geographic Coordinate: Latitude: 691744,632; Longitude: 7796284,803).

performed using the Datum WGS84 UTM zone 23S system. Postflight Terra® 3D system and Pix4UAV® Desktop softwares were used to process the images and acquire the Orthomosaic and Digital Surface Model (DSM) (Fig. 4).

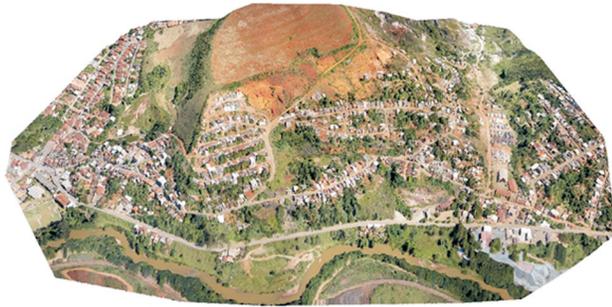
**Figure 5** - Three-dimensional perspective (3D) of the study area obtained with ArcScene®, version 10.3.1 (Geographic Coordinate: Minimum Latitude: 691341,000000, Maximum Latitude: 692625,813950; Minimum Longitude: 7795380,931400, Maximum Longitude: 7796856,871180) (Scale in 2D: XY Scale 1:7.000, Z Scale Elevation Factor: 1,5 ArcScene®).

The presentation of the three-dimensional perspective (3D) (Fig. 5) was obtained by ArcGis® ESRI software in the ArcScene 10.3.1 extension. This information was an essential base for the modeling and for the understanding of events in the area.

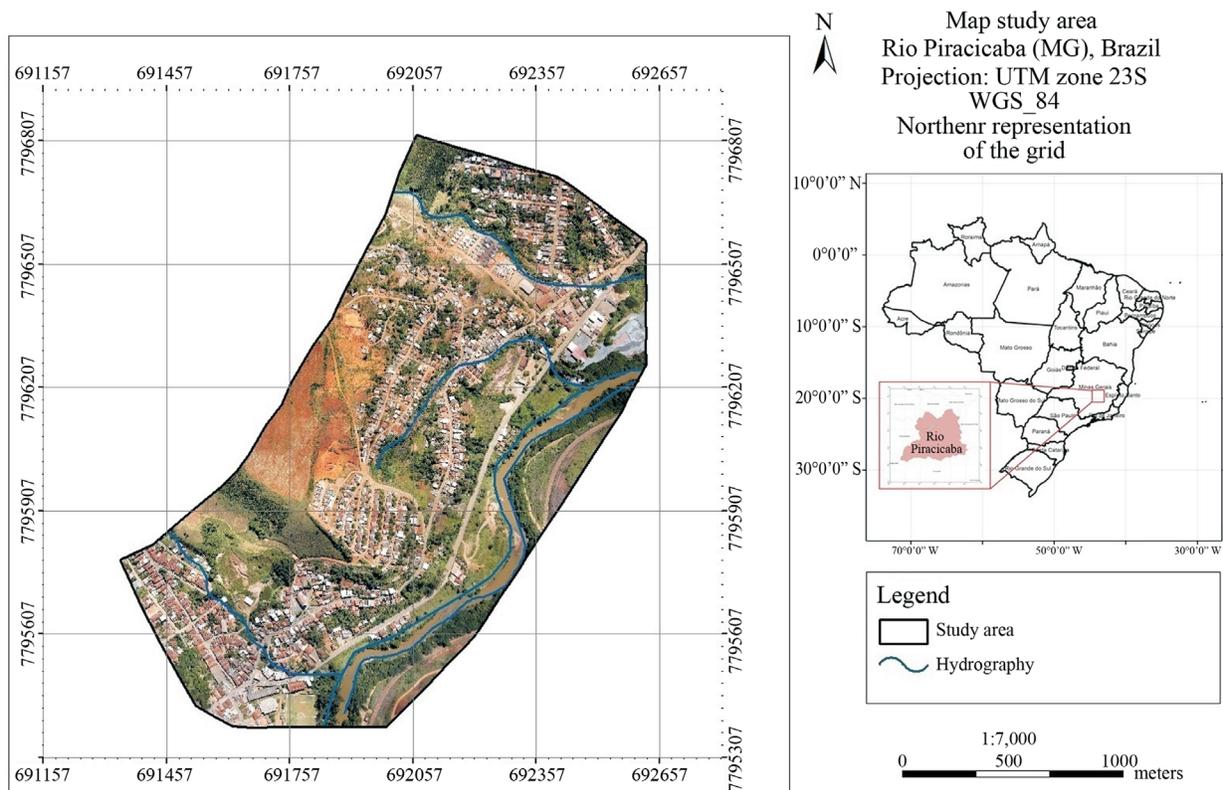
**Figure 6 - Map of the study area in Rio Piracicaba, MG.**

The points and areas mapped and the delimitation of risk sectors were plotted and organized in an RGB (3-2-1) orthomosaic (Fig. 6) obtained from the aerial photogrammetric survey by the Unmanned Aerial Vehicle (UAV) and processed with Postflight Terra® 3D and Pix4UAV® Desktop systems. This image has enabled to build the cartographic base in the GIS environment. This cartographic base, with scales varying from 1:7.000 to 1:800, aided the verification of points and the creation of the polygons of the georeferenced areas. The software used for the generation of scenarios and sectorization of risk was the ArcGis® 10.3.1, developed by ESRI (Environmental Systems Research Institute).

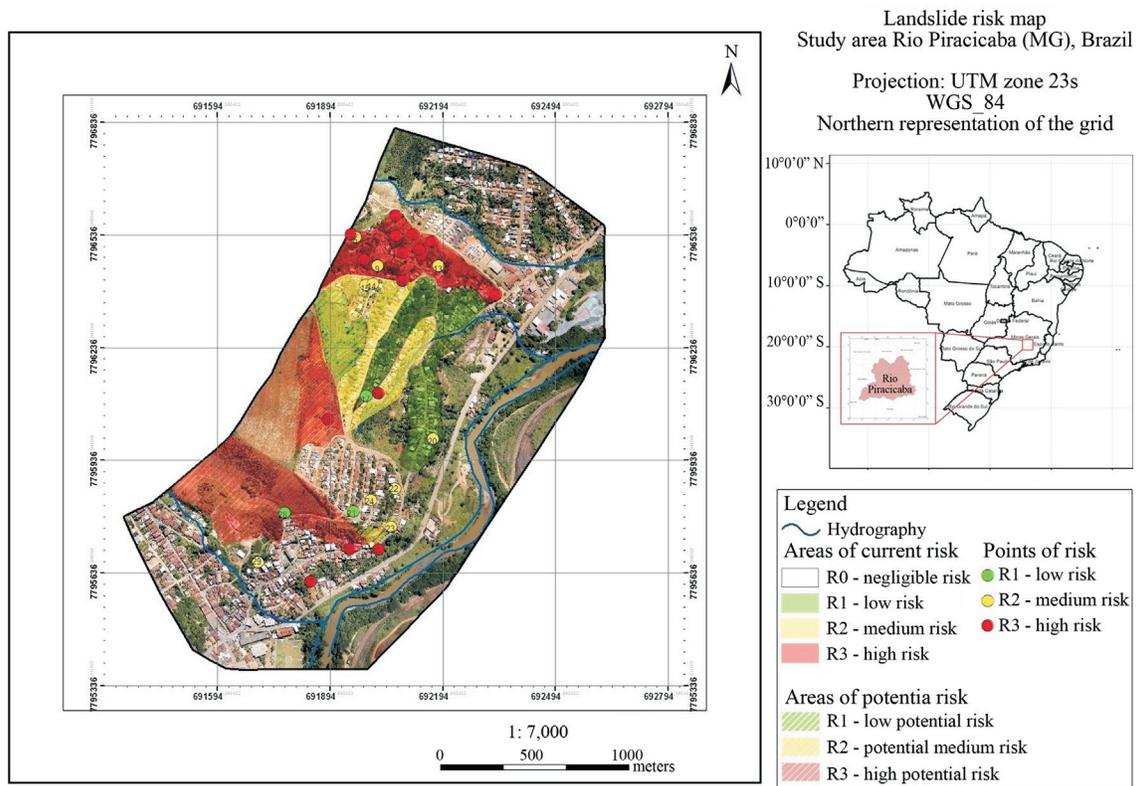
**Figure 7** - Landslide risk map: areas of current risk, areas of potential risk (susceptibility) and points of risk - urban perimeter of Rio Piracicaba, MG.

The classification of the degree of risk of the areas and points that were mapped in the four evaluated neighborhoods are shown in Table 3 and on the map presented in Fig. 7. As stated, the hierarchy was classified based on the type of use, pattern of settlement and other triggering aspects observed on the ground, in accordance with the methodology of the Ministry of Cities. Moreover, classification also took into account the diagnosis of the physical characteristics integrated into the digital cartographic data of the study area in GIS environment (digital terrain model, altimetry, slope, land use and occupation, and mass movement scars).

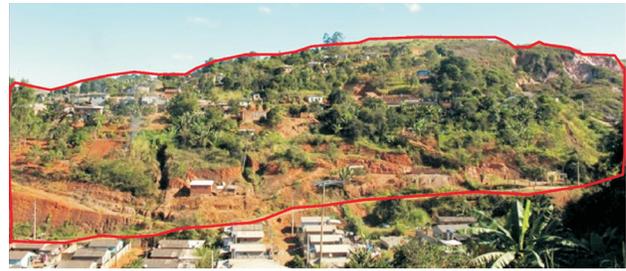
**Figure 9** - Delimitation of High-risk points and area in the Córrego São Miguel neighborhood, precarious settlements, absence of rainfall drainage, erosive process in advanced stage and mass movements scars.

increase soil saturation, especially during periods of concentrated and intense rainfall. There are many banana trees whose roots promote water retention, along with dense vegetation on the slope, which may lead to vertical overload. This combination of factors increases the risks of mass movements (Fig. 9).

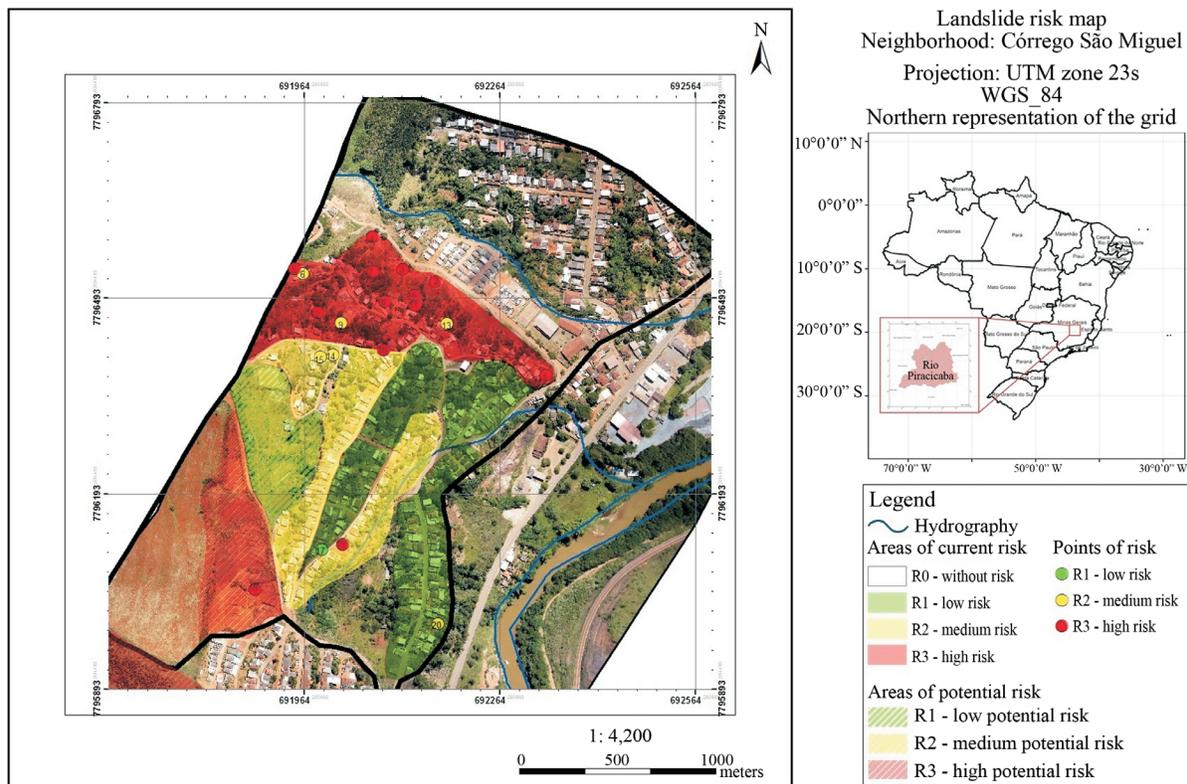
**Figure 8** - Landslide risk map of Córrego São Miguel neighborhood, Rio Piracicaba, MG.

The anthropic action, as a main environment modifier, in addition to the geotechnical, geological and geomorphological characteristics unfavorable to occupation, have allowed rating Córrego São Miguel neighborhood as the one with the greatest number of identified risk points (20), 8 areas of current risk and 2 of potential risk, which are considered priorities for immediate intervention and restructuring. It is suggested to prevent new occupations and reallocation of the population of the dwellings in the most critical situations and areas (Fig. 8).

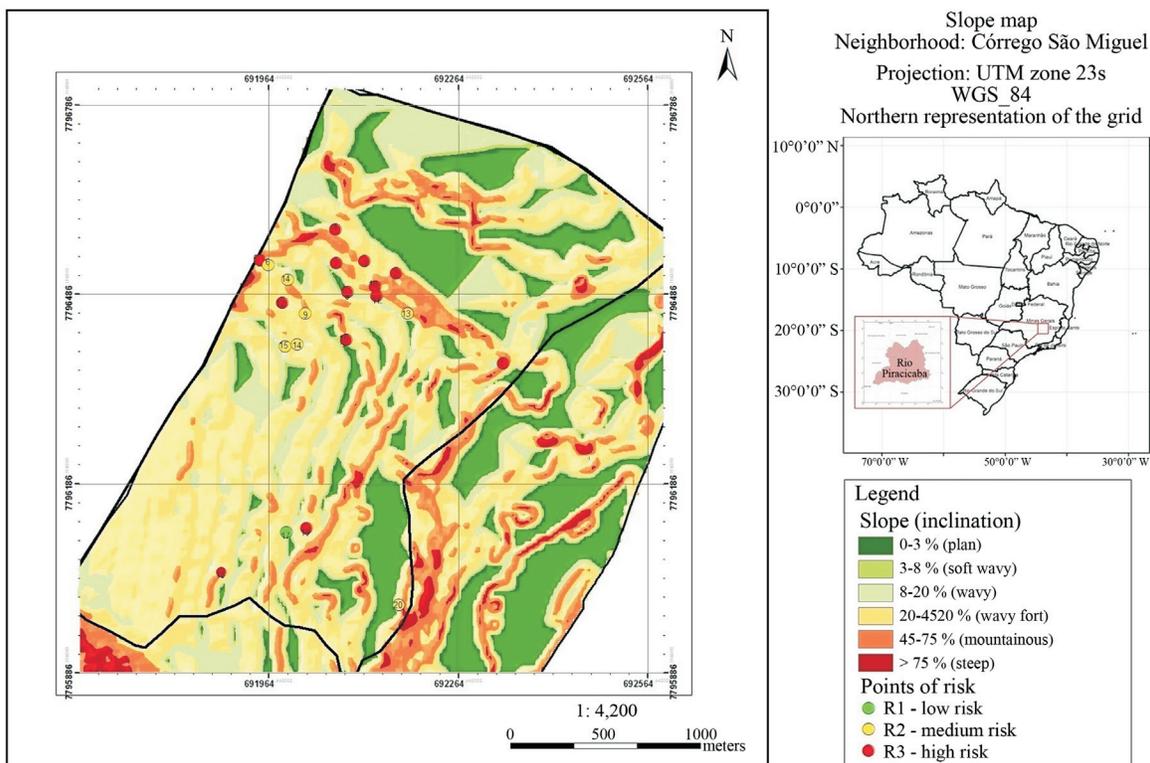
Figure 10 - Slope Map (inclination) (Córrego São Miguel Neighborhood, Rio Piracicaba, MG).

As can be seen in the declivity map with the neighborhood limit (Fig. 10), the diagnosed points of risk are mostly located in the highly hilly terrains. On these points there are shallow soils (mostly silty sand) and rock outcrops in the base of the slopes, which present a natural predisposition

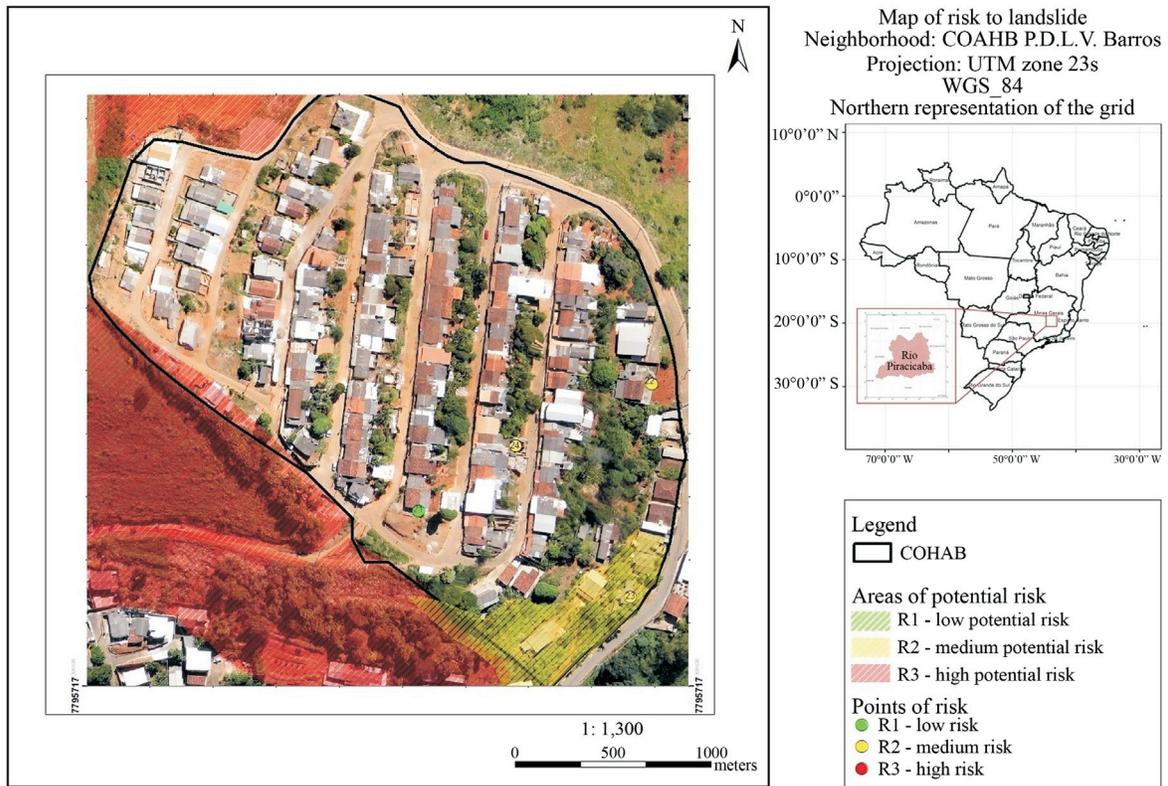
Figure 11 - Mass-movement risk map (neighborhood) COAHB Padre Levy, Rio Piracicaba, MG.

The main risk-inducing factors on COAHB neighborhood are related to slopes with more than 30 % inclination, presence of soil/rock contacts and wastewater being disposed directly on lands and roads. This constant water flow in the soil causes increased saturation, decreases strength so increasing the risk of mass movements. The points classified as low risk require monitoring of the dynamic processes identified, related to the exposed soil and the absence of a drainage system. Drainage works are necessary to solve these problems; as well as planting, to restore the vegetation cover; and containment works, to prevent the degradation to progress (Fig. 11).

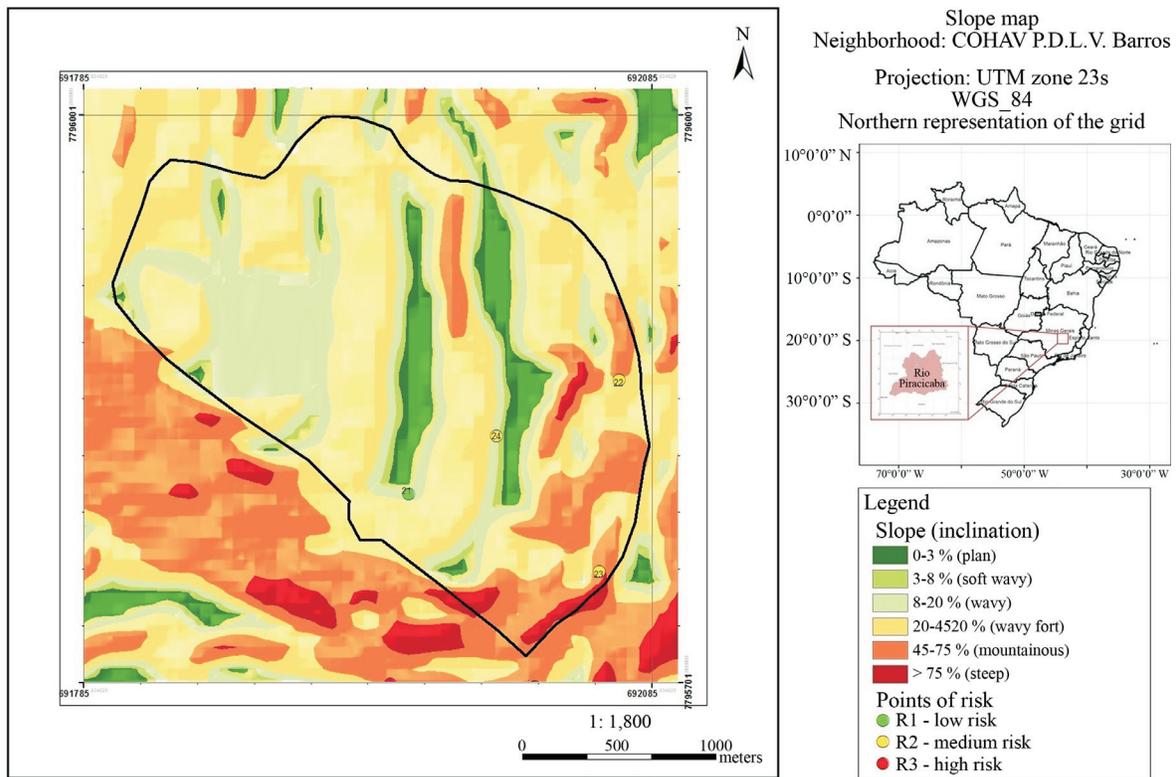
Figure 12 - Slope (inclination) map of COHAV neighborhood, Rio Piracicaba, MG.

The area classified as medium potential risk is located at the base of a slope with inclination higher than 45 % (Fig. 12). The sparse vegetation still acts as a protective layer against water erosion, but the presence of shallow soils can control landslides during heavy rain periods. Thus, it is necessary to monitor the buildings that are located below this slope in order to avoid human and economic losses.

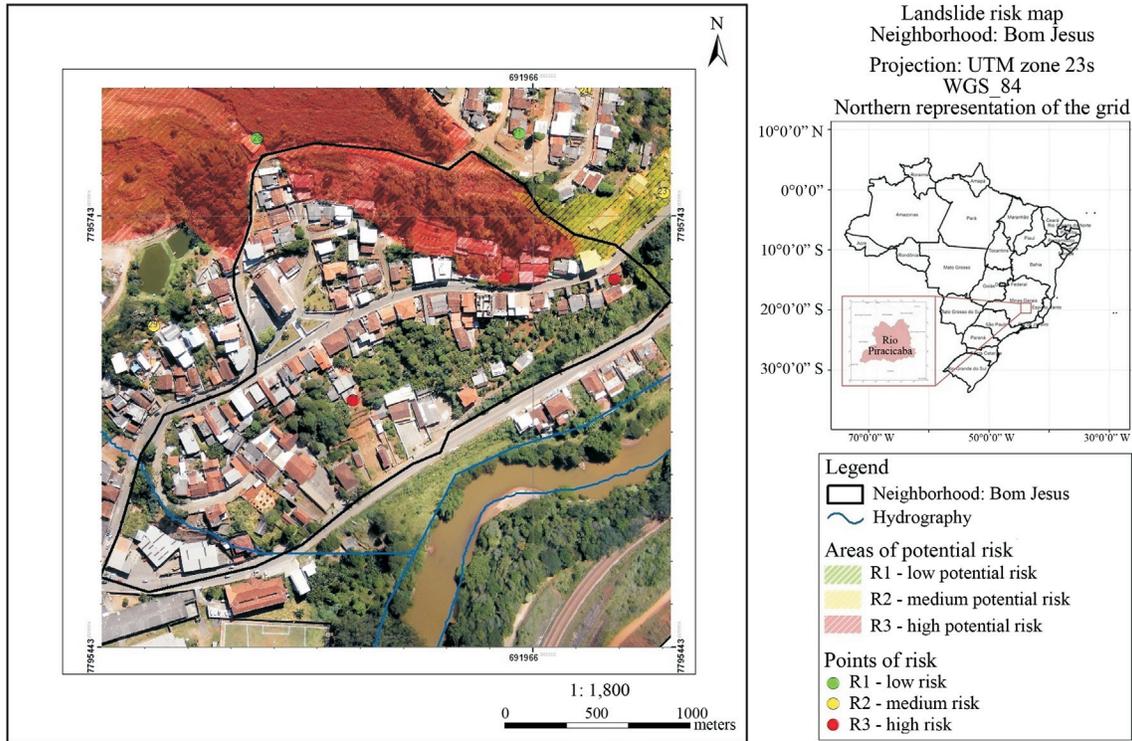
Figure 13 - Mass-movement risk map of Bom Jesus neighborhood, Rio Piracicaba, MG.

In Bom Jesus neighborhood, 3 high-risk points were registered. The area demarcated as high potential risk (Fig. 13) corresponds to the face of a mountainous relief

slope, in which mass movement scars with recomposed crawling vegetation were identified; however, the dwellings below this slope should be monitored.

High-risk points are associated with landslides and presence of housing on the top. Unconsolidated materials and volumes of debris were identified at the talus deposit

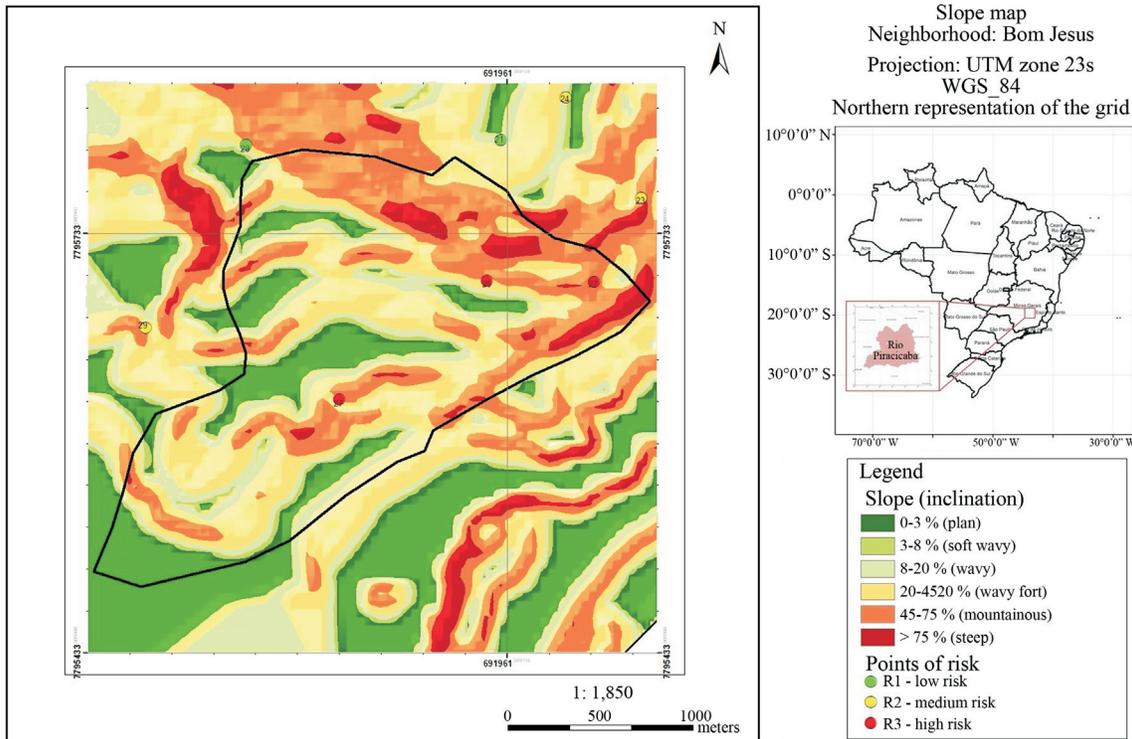
Figure 14 - Slope map (inclination) of Bom Jesus neighborhood, Rio Piracicaba, MG.

These high-risk points must have a solution immediately, probably by a retaining wall. As can be seen in the declivity map (Fig. 14), this neighborhood is mostly located in an area of flat to highly undulating relief and presents a better constructive pattern. However, it should be monitored in order to avoid the emergence of risk-triggering agents.

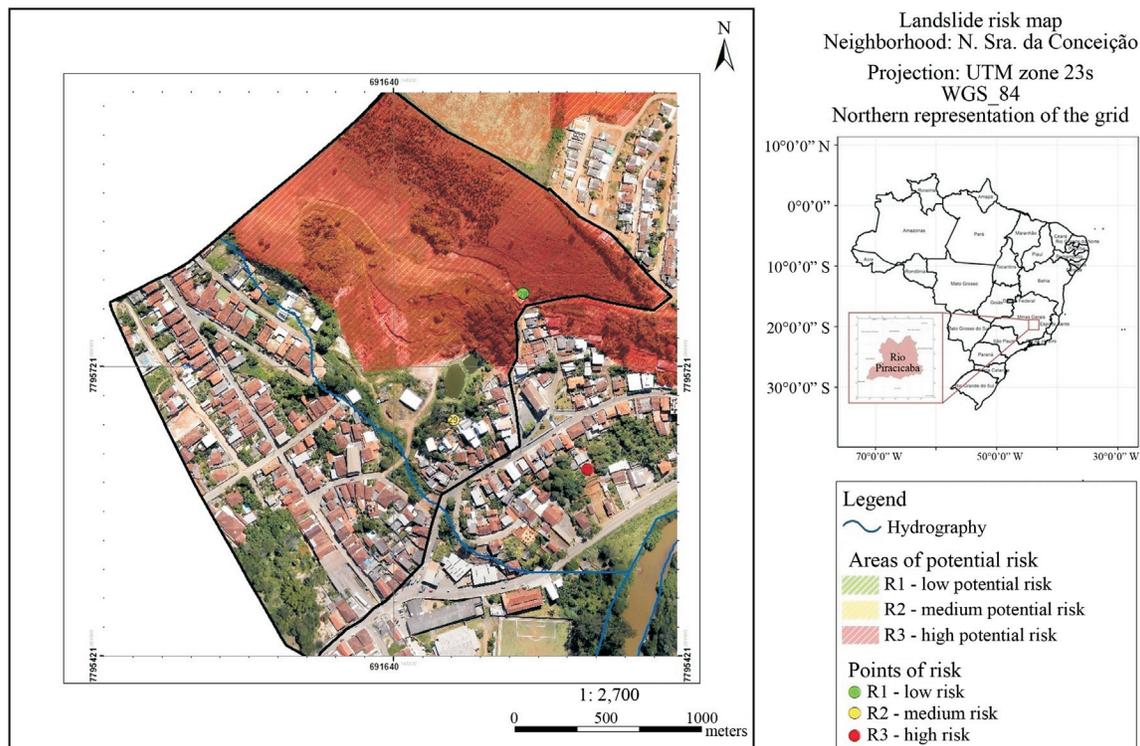
**Figure 15** - Landslide risk map, Nossa Senhora da Conceição neighborhood, Rio Piracicaba, MG.

The neighborhood of Nossa Senhora da Conceição (Fig. 15) was the neighborhood that appeared to have better conditions of urban planning, despite the insufficiency of existing drainage systems. Only one medium-risk and one low-risk point were identified as presenting predisposing geological-geotechnical conditions. Erosive processes at an early stage of development were observed, as well as old mass-movement scars on a slope  $> 45\%$  with poor natural drainage, classified as high potential risk. In the municipality's master plan, these two listed sites are located in an environmental protection zone, which restricts their urban occupation and use, in order to protect and maintain its natural aspect.

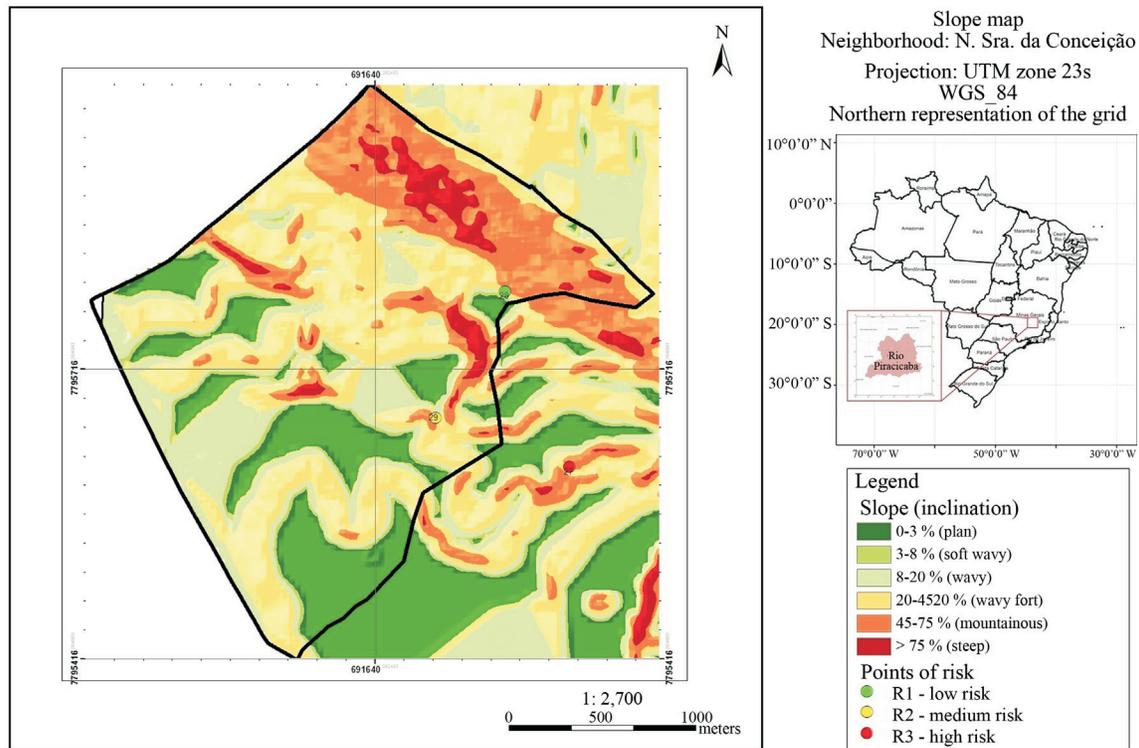
**Figure 16** - Slope map (inclination) Nossa Senhora da Conceição neighborhood, Rio Piracicaba, MG.

According to the declivity map (Fig. 16), the dwellings are mostly located in areas of flat to highly undulating relief.
