Pullout Testing of Soil Nails in Gneissic Residual Soil

A.C.N.B. Arêdes, E.A.G. Marques, A.H.C. Oliveira

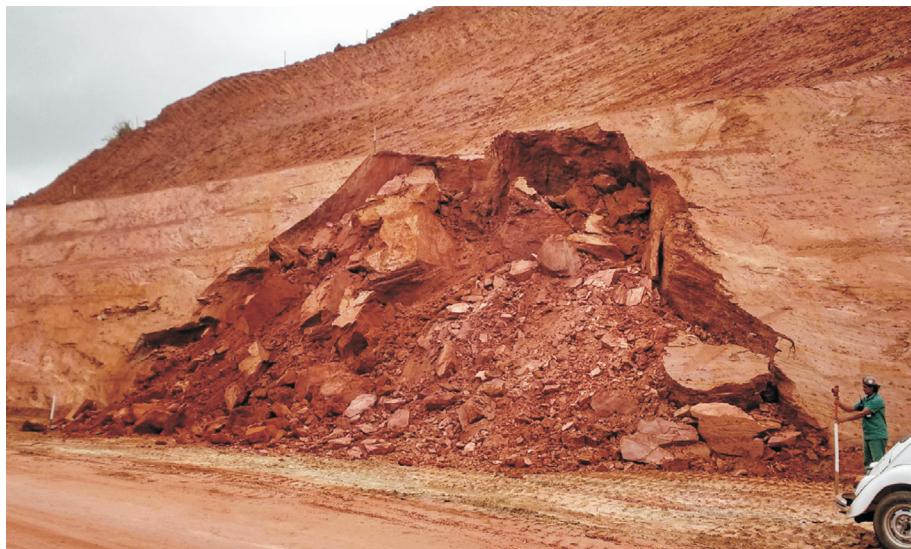
Figure 2 - Front view of failure occurred in the studied area.

this slope that occurred during the dry season of 2015, between July 4th and 6th. At the time when the slope movement occurred, there were no drainage devices installed on the slope. A back analysis of this slope failure was presented by Arêdes *et al.* (2017).

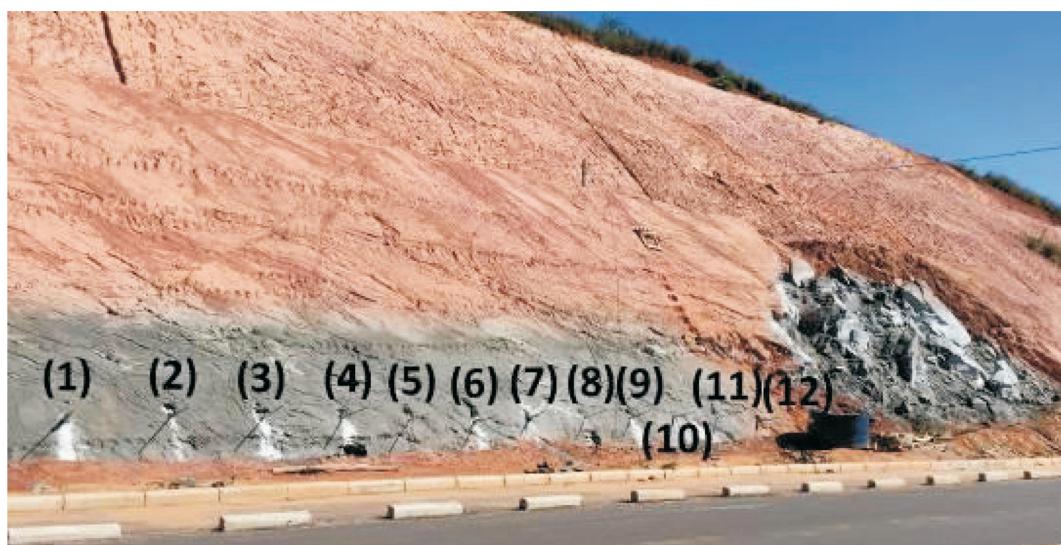
Figure 3 - Position of the soil nails.

The twelve holes drilled to install the nails were arranged in a single line with an average horizontal spacing of 1.5 m (Fig. 3). Among the twelve holes, six were drilled with 6 m length and an average diameter of 100 mm (nails 1 to 6 - Fig. 3), while the other six were drilled with 4 m length and the same average diameter (nails 7 to 12 - Fig. 3). Drilling of nails 2, 3, and 4 was done with a hydraulic drilling rig, while all other nails were drilled with a mechanical auger. After the drilling process, a PVC pipe was used to wash the holes until clean water came back through the orifices. The soil nails were installed at a 15° downward horizontal inclination.

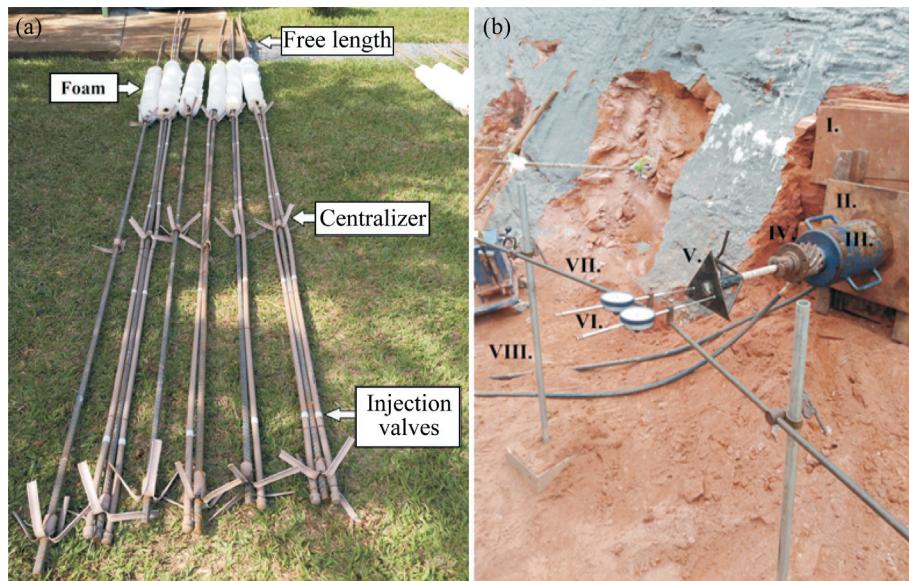
Figure 4 - Components of the pullout test: (a) Bar for insertion into the prepared hole. (b) Arrangement of the pullout test system.

After the nail was prepared (Fig. 4a), it was inserted into the hole, leaving a gap of 1 m from the surface for the purposes of the pullout test. To prevent the cement grout from filling the first meter of the hole, the bar was wrapped with foam along this length.

The setup (Figure 4b) of the pullout test was composed by the following equipment: pieces of wood (I), welded steel plate (II), hydraulic jack cast with a capacity of 50 tons (III), set for locking the steel bar (IV), steel plate for supporting extensometers (V), mechanical strain gauges

(VI), arms for pivoting and adjusting the position of the extensometers (VII), and a concrete-based fixed support for the pivot arms (VIII).

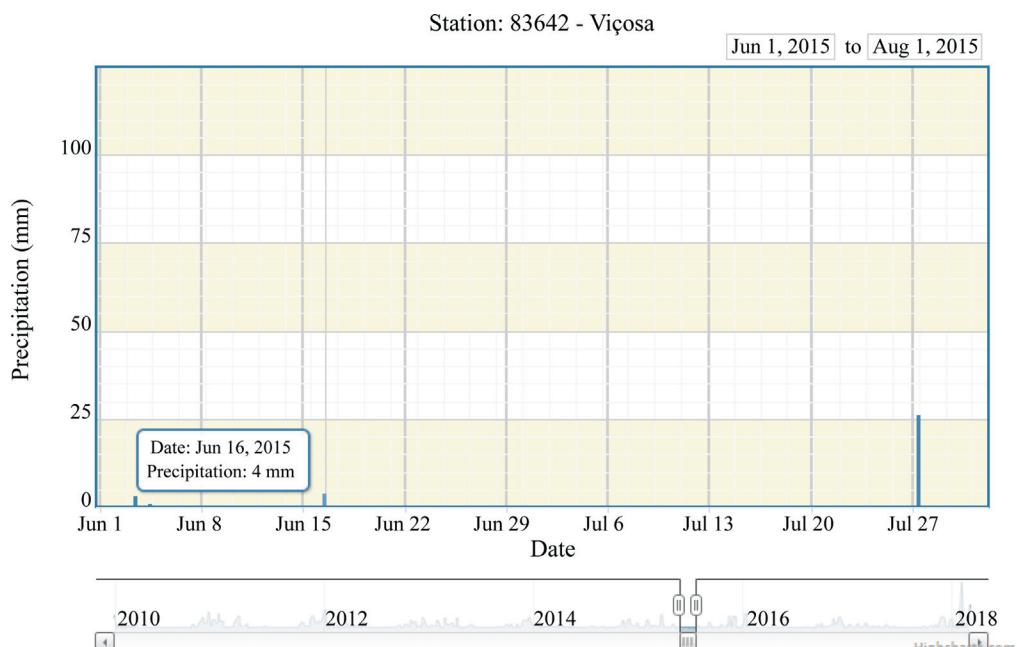
Figure 5 - Precipitation information about Viçosa between June 1st and August 1st. Source: INMET, 2019.

According to INMET (2016), there was 0 mm of rainfall in the city of Viçosa during this period, with the previous rainfall registered on June 16th with 4 mm, as shown in Fig. 5.

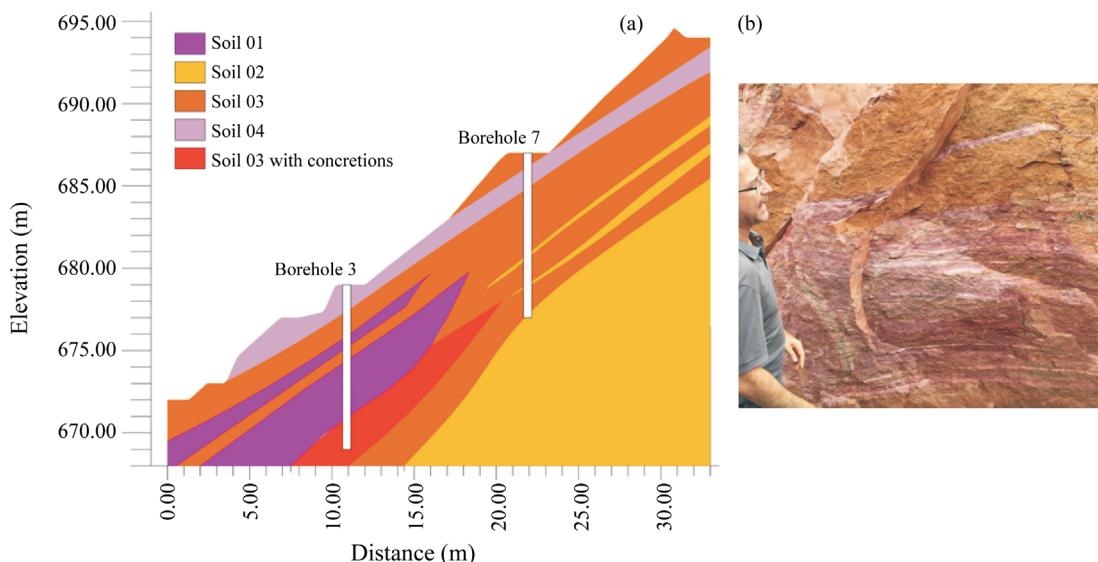
Figure 6 - Geotechnical characterization of the study area. (a) Geological-geotechnical cross-section. (b) Detail of the interface between the layers of Soils 03 (upper) and 01 (lower) and failures.

A visual-tactile examination of the disturbed samples was used to elaborate a representation of the geological-geotechnical cross-section of the slope, aligned with two boreholes, as shown in Fig. 6a. The field investigation revealed four different types of soil, all characterized as gneissic residual soil with many relict structures: faults, foliation (preserved), and manganese lenses. The mineralogy

was mainly composed of quartz, feldspar, and mica. The groundwater table was not found during drilling.

Soil 1 was characterized as a fine silty sand and was dark red and purple in color; Soil 2 presented a silt-sandy texture and had an ochre color; Soil 4, which showed a lighter coloration that was rosier with grayish tones, displayed kaolinized levels and was classified as a silt with fine sand; finally, Soil 3, which was a mixture of soils 1 and 2, had variegated colors. Figure 5b shows the interface between Soils 2 (above) and 1 (below) displayed on the failure plane, with some relict faults planes transversal to the cut slope.

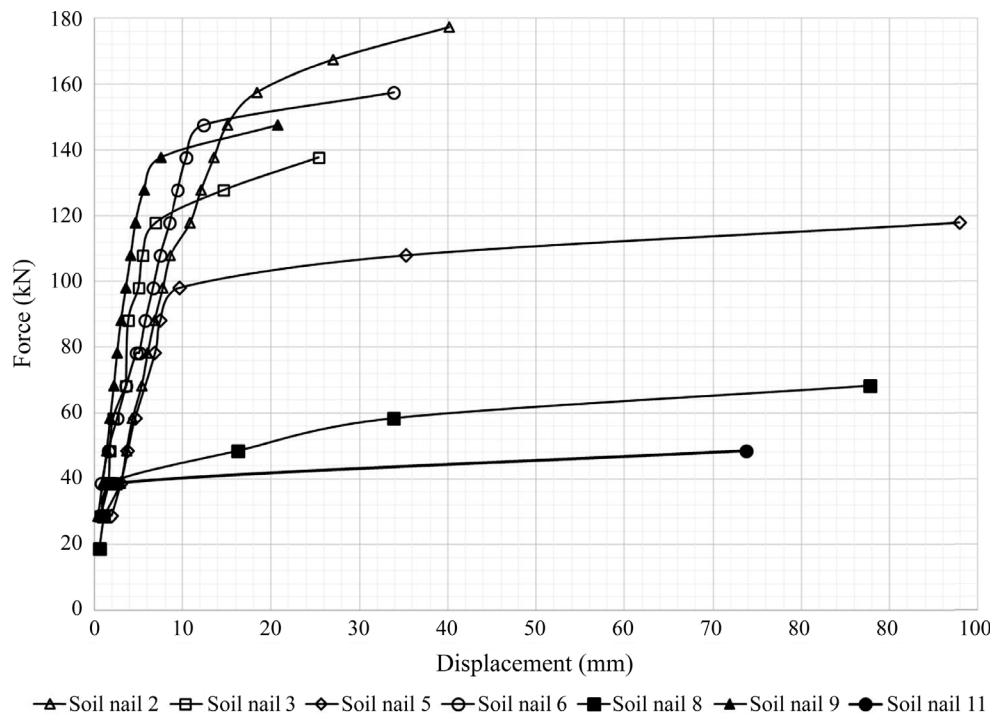
**Figure 7** - Force vs. displacement of the soil nails.**Table 4** - Results of maximum load and corresponding displacement in the pullout tests of the soil nails.

During the testing routine, the hydraulic jack presented a deficiency that prevented the conduction of pullout tests on soil nails 4 (5 m, 1 incomplete reinjection) and 10 (3 m, 1 reinjection). As previously mentioned, the results of nails with 1 incomplete reinjection (nails 1, 4, 7, and 12) were disregarded in this study. Thus, only seven of the tests that were originally planned could be effectively considered valid. Figure 7 shows the results of the pullout tests, where unfilled markers represent the nails with 5 m of an-

chored length, and filled markers represent the tests with 3 m of anchored length.

A summary of the valid results is shown in Table 4. The maximum values of axial tensile load were obtained from the point of greatest curvature in the graphs of Fig. 7 that is, the maximum tensile force supported by the nail without excessive displacement.

For soil nails with 3 m of anchored length, the load-displacement curves demonstrated that nails that used only sleeve grout (soil nails 8 and 11) had an average pullout force of 44 kN. Due to an overestimation of the maximum strength attributed to nail 11, its corresponding curve was obtained from a small number of stages. Even so, it was

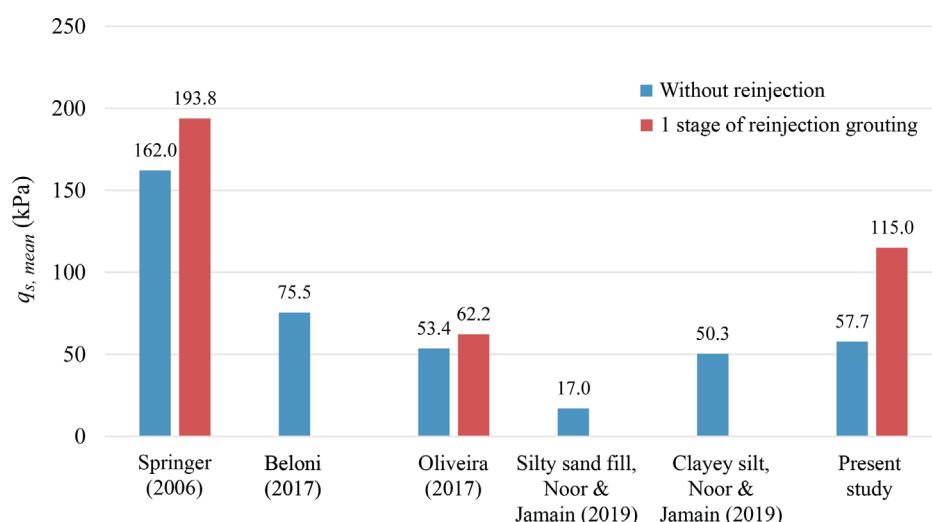
**Figure 8** - Comparing values of $q_{s,mean}$ from this study with some results found on literature.

Figure 8 shows a comparison between mean values of q_s for nails without reinjection (57.7 kPa) and nails with 1 stage of reinjection (115.0 kPa), using values presented in the literature and considering tests with 3 and 5 m of anchored length. The values observed in the present study were compared with results obtained from similar soils by the aforementioned authors. The values for soil nails without reinjection were closer to the ones reported in other studies, mainly those by Oliveira *et al.* (2017) and Noor & Jamain (2019).

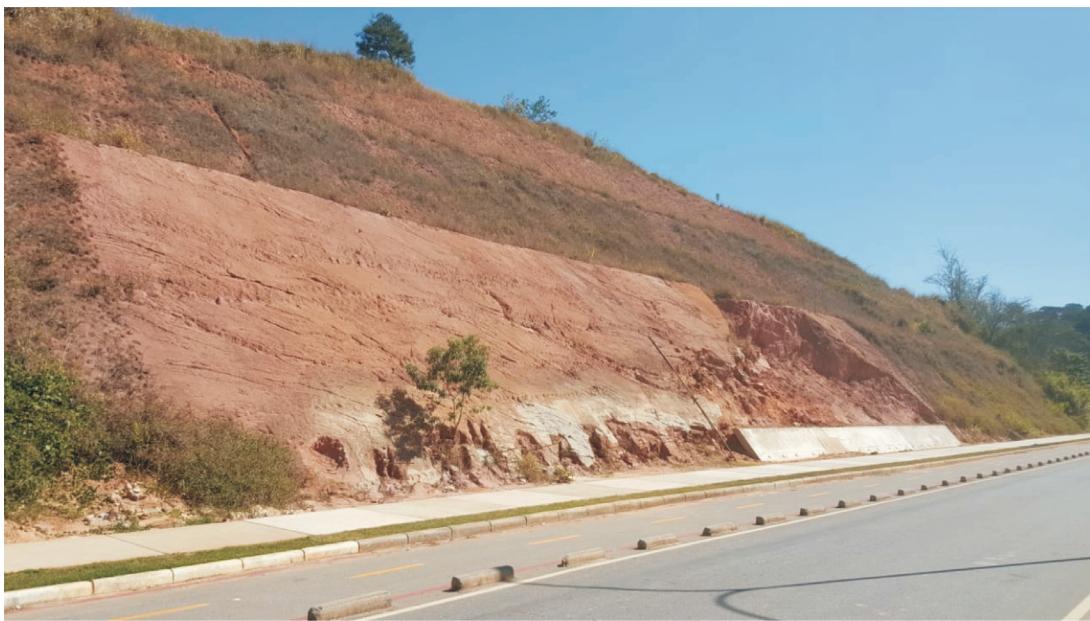
Figure 9 - Current lateral view of the slope.

The study of this site presented by Arêdes *et al.* (2017) attested to the overall stability of the slope, making it unnecessary to perform soil nailing to stabilize the slope. Therefore, a decision was made to implement a small concrete foot wall and to fill the spaces generated by the failure with rip-rap. In addition, a drainage system was installed on the berms.

Figure 9 shows the current lateral view of the slope.
