Soils and Rocks
v. 37, n. 2

Lessons From The Lives of Two Dams

J.K. Mitchell

Abstract. Many embankment dams completed during the first six decades of the 20th century have been found deficient relative their ability to resist currently anticipated levels of seismic shaking and probable maximum flood. In this Fourth Victor de Mello Lecture, two recent case histories are described. One is a hydraulic fill structure completed in 1920 that is founded on alluvial material, some zones of which are susceptible to liquefaction. The other is a zoned earthfill dam completed in 1956 that is founded over a channel filled with loose, uncompacted, hydraulically placed tailings from gold mining operations. Each dam has been upgraded in phases over periods of several decades using different strategies and ground improvement technologies to improve stability and reduce failure risks. Several take away lessons from these experiences concerning current risk mitigation strategies, the importance of correct soil and site characterization, and implementation and effectiveness of different ground stabilization and improvement methods are presented.

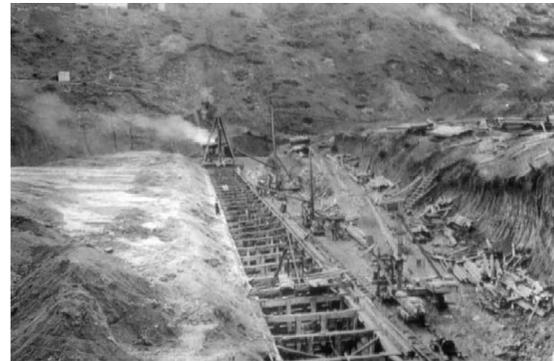
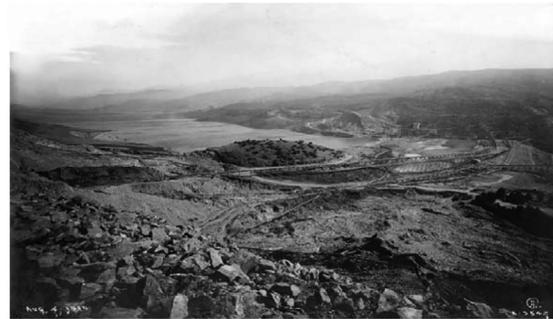
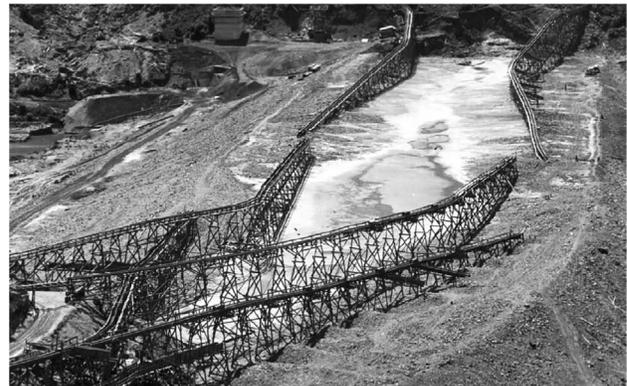
(a) Core trench to bedrock with shoring in 1917

(b) Hydraulic fill construction site in 1919

(c) Hydraulic fill transportation and deposition in 1920

Figure 1 - Stages in the construction of San Pablo Dam (East Bay Municipal District construction photos Reproduced and reported by TNM Terra Engineers, Inc., Ninyo and Moore, 2007). (a) Core trench to bedrock with shoring in 1917; (b) Hydraulic fill construction site in 1919; (c) Hydraulic fill transportation and deposition in 1920.

Photos of the construction of the dam illustrating the excavation for the core trench and placement of the hydraulic fill embankment materials are shown in Fig. 1. The original hydraulic fill embankment construction was completed in 1921. Tests on a few sandy samples of the embankment materials in the 1960's and 1970's indicated potentially liquefiable behavior. Evidently this led to the assumption of a liquefiable embankment because it was a hydraulic fill, and hydraulic fills of cohesionless materials are invariably of low relative density and high liquefaction potential unless densified following deposition.

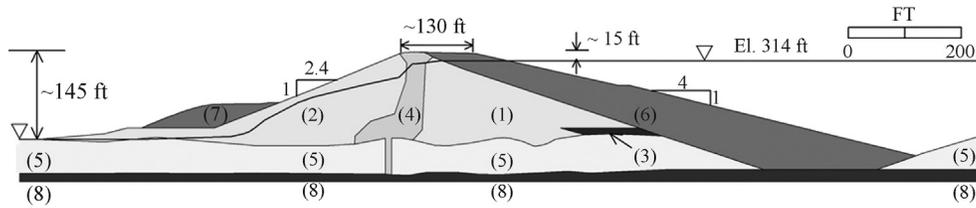
Figure 2 - Composite maximum section of San Pablo dam after buttress additions. (adapted from Moriwaki *et al.*, 2008). (1) upstream shell (hydraulic fill); (2) downstream shell (hydraulic fill); (3) ponded clay/silt; (4) core and key trench (hydraulic fill); (5) alluvial foundation soils; (6) upstream buttress (well-compacted) completed in 1979; (7) downstream buttress (less-compacted) added in 1967; and (8) bedrock.

A small downstream buttress fill was constructed in 1967 to improve seismic stability. Then, following the 1971 San Fernando Earthquake in southern California, a much larger upstream compacted fill buttress extending to bedrock was completed in 1979. Construction of this buttress required draining the reservoir, with its attendant depletion of the area's water supply capacity and disruption of recreational use of the reservoir. A cross section of the maximum embankment section with both the 1967 downstream stabilizing berm and the much larger 1979 upstream berm in place is shown in Fig. 2.

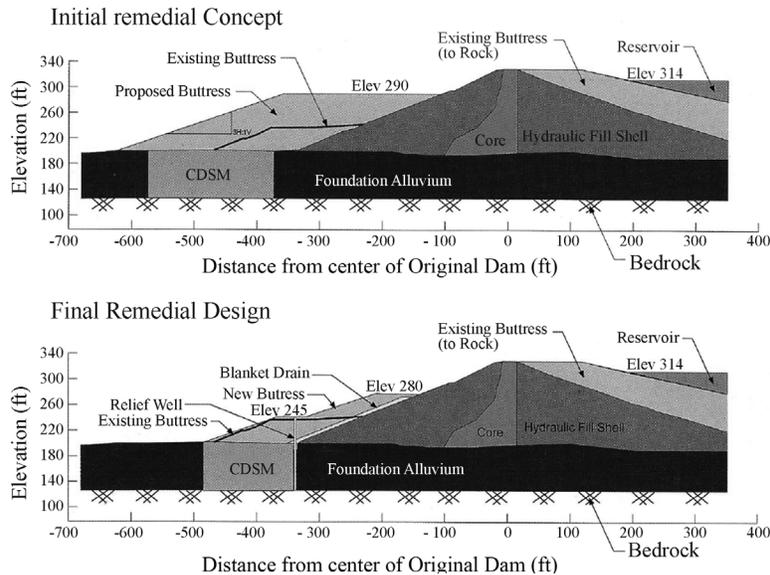
Figure 3 - Remedial designs for mitigation of seismic risk to San Pablo Dam (from Yiadom & Roussel, 2012).

A new seismic stability evaluation was completed in 2004 assuming a liquefiable embankment and a M7.25 earthquake on the Hayward Fault which passes just 3 km southwest of the dam. The results indicated the potential for vertical slumping of up to 10.7 m and overtopping of the dam by the impounded reservoir. To provide additional freeboard for the short term, the reservoir level was lowered by 6 m. Consideration was given to completely rebuilding the dam; however, this would have required again draining the reservoir, an action that had considerable opposition. Instead, an in-place alternative was chosen that consisted of Cement Deep Soil Mixing (CDSM) to bedrock at depths of up to 36.5 m in the downstream foundation alluvial soils and construction of a large buttress fill on the downstream embankment slope, shown as Initial Remedial Concept in Fig. 3, from Yiadom & Roussel (2012).

This re-characterization of the hydraulic fill embankment material from liquefiable to non-liquefiable, fine-grained soil enabled significant reductions in the required sizes of the 2010 buttress and CDSM block, as may be seen in Fig. 3 by comparing the Final Remediation Design with the Initial Remedial Concept. Seismic deformation analyses of the maximum composite dam cross-section were done using computer program FLAC with input ground motions that had a peak acceleration of 0.98 g and associ-

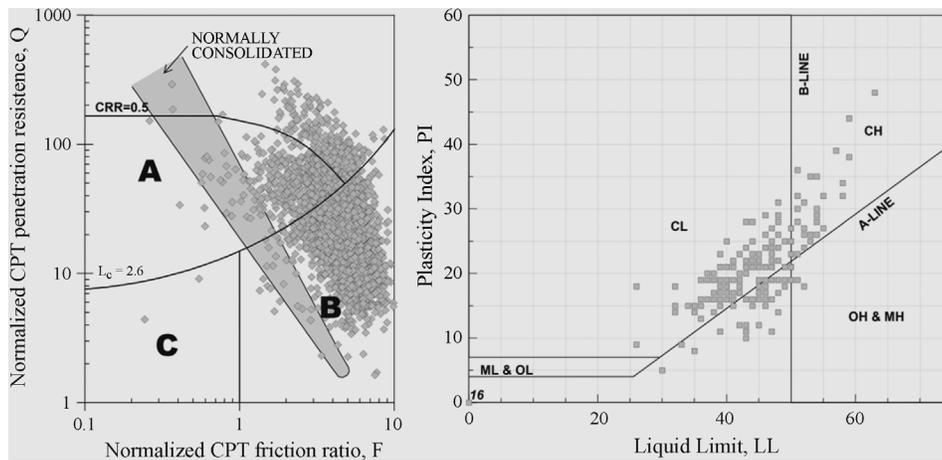
Figure 4 - CPT and Classification data for the San Pablo Dam hydraulic fill shell material. Zone A: Cyclic liquefaction possible; Zone B: Cyclic liquefaction unlikely; Zone C: Flow/cyclic liquefaction possible (from Moriwaki *et al.*, 2008).

An extensive new field investigation program was then completed that included many cone penetration tests (CPT) and borings into both the embankment and foundation materials. The results of these field investigations and laboratory tests on representative samples are described in detail by Moriwaki, *et al.* (2008). They described the sampled hydraulically placed material as consistently very clayey, very "lumpy", and over-consolidated. Of special interest is Fig. 4, taken from that reference, which shows CPT and plasticity data for the hydraulic fill embankment shell materials, zones (1) and (2) in Fig. 2. This data shows clearly that this material is not susceptible to liquefaction, as had been assumed for the previous evaluations of San Pablo Dam and for the Initial Remedial Concept in Fig. 3. In retrospect this finding is not surprising given that the material used for the hydraulic fill came from the colluvial

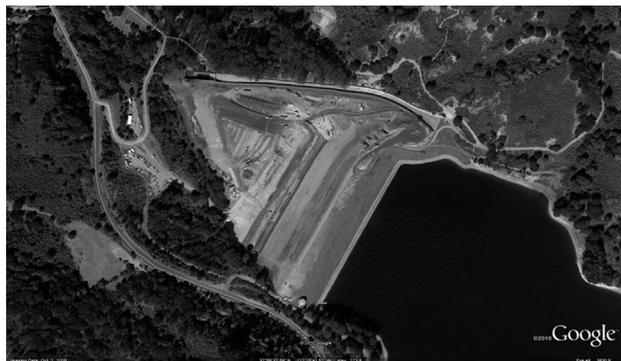
Figure 5 - San Pablo Dam in 2010 after seismic remediation using cement deep soil mix in the downstream foundation and a downstream stability berm (Google Earth, Imagery Date 10/2/2009).

trol of the material. Another cost saving feature was that the spoils from the deep cement mixing could be incorporated into the new downstream buttress. An aerial photo (Google, 2012) of the project after completion is shown in Fig. 5. This project is an excellent illustration of the importance of correct soil identification and classification prior to analysis and design of risk mitigation strategies for existing dams.

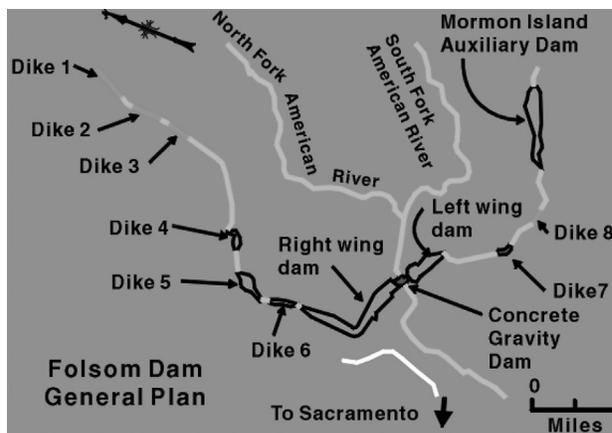
Figure 6 - Components of the Folsom Project near Sacramento, California.

The Mormon Island Auxiliary Dam (MIAD) forms a part of the Folsom Project located on the American River about 32 km (20 miles) northeast of Sacramento, California. This project provides water supply, hydroelectric power, and flood protection for a large metropolitan area. It consists of a concrete main dam, right and left wing dams, the zoned and rolled earthfill MIAD, and eight earthfill dikes that are needed to contain Folsom Lake. A plan showing these features is given in Fig. 6. Figure 7 is an aerial photo showing MIAD as it appears at present (Google Earth, 2013).

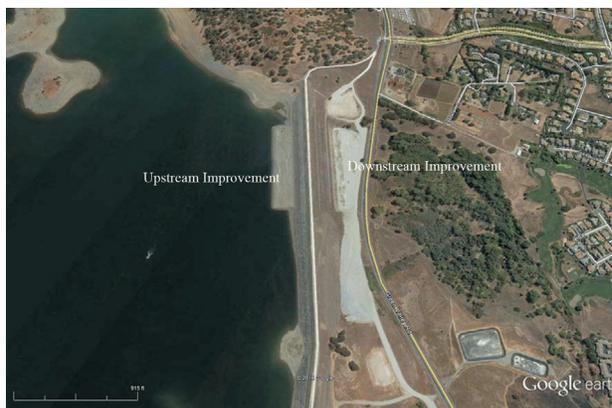
Figure 7 - Aerial view of Mormon Island Auxiliary Dam as it appeared in August 2013. Critical section over potentially liquefiable foundation material extends about 300 m from the left abutment (Google Earth, Imagery Date 8/13/2013).

900 ft (275 m) long by 200 ft (61 m) wide in plan, in the area labeled “Downstream improvement” in Fig. 7. Excavation into the existing downstream embankment was required in order to develop a level working platform, Fig. 13, for installation of 1.2 m (4 ft) diameter wet, bottom feed, vibro-replacement stone columns and the upstream and downstream drainage zones that are composed of 250 mm diameter gravel columns on 1.0 m centers installed using a vibro-pipe. It is important to note that excavation into the downstream slopes of embankment dams is not without risk owing to reduced seepage paths and lower factors of safety against stability failure while the excavation is open, both of which must be accounted for in assessing risk during construction.

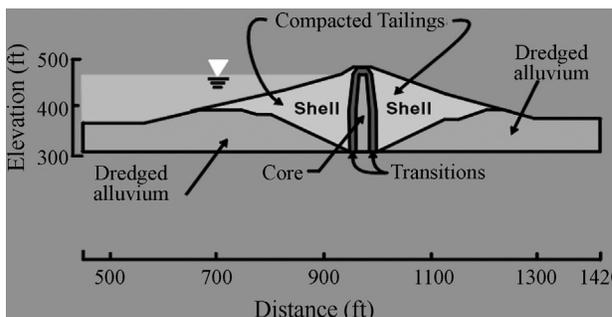
Figure 8 - Cross section of the Mormon Island Auxiliary Dam as constructed in 1956.

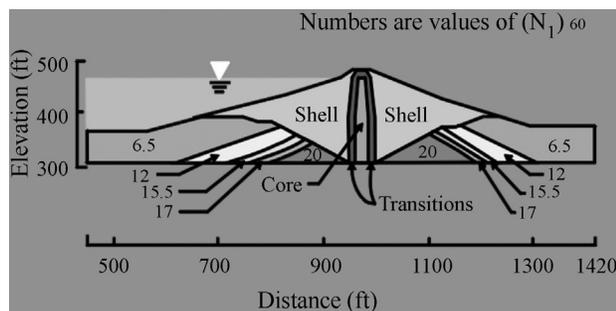
Figure 9 - Characterization of the MIAD foundation material in terms of SPT values of $(N_1)_{60}$ for use in liquefaction potential assessments.

The results of field and laboratory tests were used to develop the distributions of normalized SPT (Standard Penetration Test) values of $(N_1)_{60}$ in the foundation that are shown in Fig. 9. These values were used to evaluate factors of safety against liquefaction and for the establishment of parameters needed for dynamic deformation analyses. Ground improvement was implemented beneath both the upstream and downstream embankment toe areas to mitigate the liquefaction risk and to limit dynamic displacements.

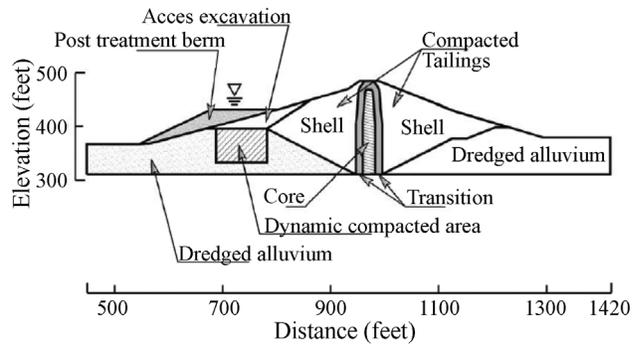
Figure 10 - Ground improvement design intended for mitigation of liquefaction risk beneath upstream embankment of Mormon Island Auxiliary Dam. DDC completed in 1990.

Owing to severe drought conditions in California in the late 1980s the reservoir level was low, and this made it possible to undertake deep dynamic compaction (DDC) in the dry from the upstream embankment. As shown in Fig. 10, an access excavation was made to provide level ground for carrying out the work. A block of densified soil was formed by repeated dropping of a 2.0 m (6.5 ft) diameter steel drop weight of 31.75 tonnes (35 tons) over a 244 by 46 m (800 by 150 ft) treatment area. The drop height of 32.9 m (108 ft) corresponded to a free fall distance of 30 m (98.4 ft). Three coverages of the area were made, with 30 drops at 15.2 m (50 ft) center to center drop point spacing for the first, or primary, coverage, 30 drops at points splitting the primary coverage spacing for the second coverage, and 15 drops at points splitting the secondary coverage for the third coverage. Finally surface "ironing" was accomplished using 2 weight drops from a height of 10 m (30 ft) at adjacent points to cover the entire area. Finally, the access excavation was re-filled, and a post treatment berm was placed on the upstream slope, as shown schematically in Fig. 10. The photograph in Fig. 7 shows this berm extending from the upstream slope into the reservoir following subsequent increase in the reservoir water level.

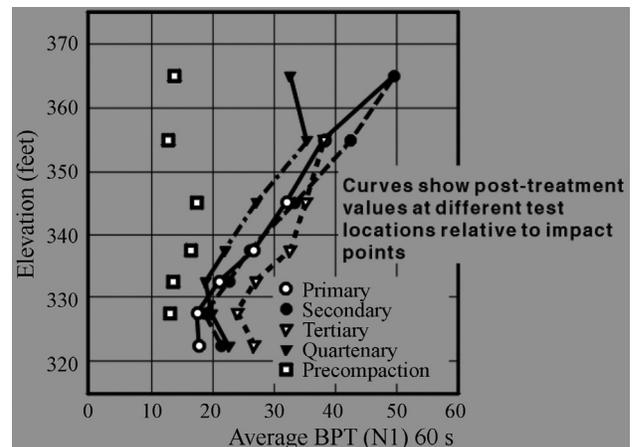
Figure 11 - Pre- and post-deep dynamic compaction Becker Penetration Test equivalent $(N_1)_{60}$ values beneath the upstream slope of Mormon Island Auxiliary Dam.

The effectiveness of the DDC can be seen in Fig. 11, which shows values of Becker Penetration Test (BPT) re-

sistance, converted to equivalent SPT values of $(N_1)_{60}$, as a function of elevation. The BPT measures the number of blows to drive a 168 mm (6.6 in) outside diameter double-walled casing a distance of 0.3 m using a double-acting diesel pile driving hammer. This test is useful in soils containing gravel and cobbles, where difficulties are often encountered when using the SPT. The decrease in penetration resistance with depth in Fig. 11 is characteristic of the DDC method for soil improvement, with an effective treatment depth of about 10 m (35 ft) being about the maximum attainable when heavy weights are used in soils of no to low plasticity. As shown in Fig. 11, the DDC was unable to densify the soil within the treatment zone over the full depth to the underlying bedrock.

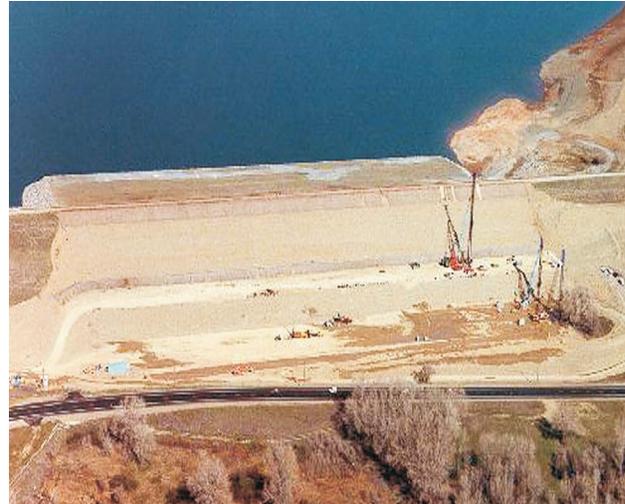
Figure 13 - Installation of stone columns and gravel mini-column drains beneath the downstream embankment of Mormon Island Auxiliary Dam in 1994. Note the excavation and steepened slope needed for development of a working platform and for optimization of the improvement zone location for its effectiveness as a key block.

It is imperative to keep in mind, however, that whenever a project involves excavation into the downstream slope; e.g., during the stone column and drain installation, Fig. 13, or into the foundation, as was necessary for the key block construction at MIAD, Fig.16, there may be increased seepage as well as a temporary decrease in factor of safety against stability failure while the excavation is open that must be evaluated and assessed in terms of increased failure risk.

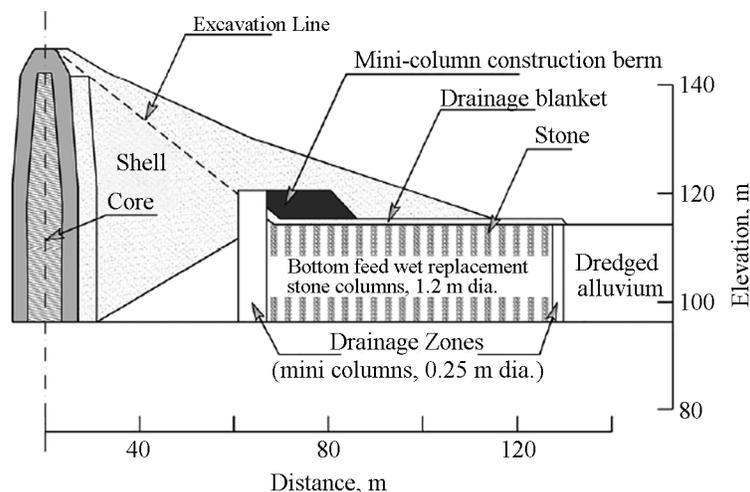
Figure 12 - Downstream foundation improvement for reduction of seismic failure risk at Mormon Island Auxiliary Dam. Construction was completed in 1994.

Following an extensive testing program for determination of the most suitable methods for in-place improvement of the downstream foundation material, the system shown schematically in Fig. 12 was designed, with construction completed during 1993-1994. The improvement zone was a strip along the downstream toe of the dam that is

The primary purpose of the stone columns was to densify the loose liquefiable dredged alluvium foundation material so that it would not liquefy under the design earthquake. The upstream and downstream drainage zones are intended to intercept pore pressure plumes migrating towards the stone column treated zone in the event liquefaction develops in the adjacent untreated dredged alluvium during an earthquake. Prevention of pore pressure increases in the stone column zone is important for maintenance of shear strength during and after shaking.

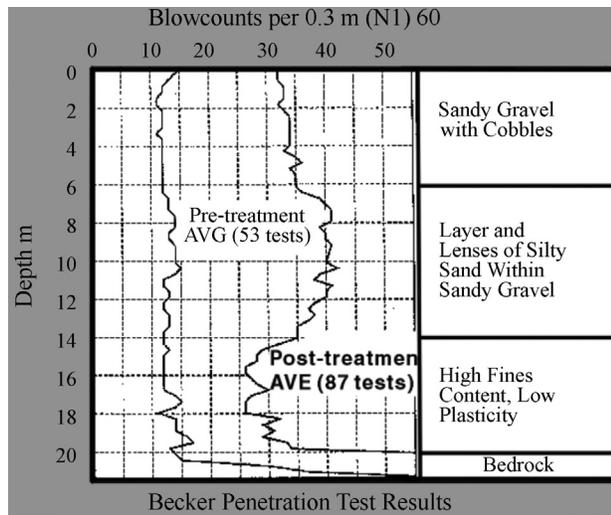
Figure 14 - Penetration resistance profiles in the downstream stone column treatment area, Mormon Island Auxiliary Dam.

The profile through the dredge spoils in the stone column area indicated that the upper 4.5 to 6 m contains coarse sand to cobble size material, and the lower 3 to 6 m is silty sand to silty clay with 10 to 77 percent fines, with an average fines content of 30 percent (Allen *et al.*, 1995). The pre- and post-treatment penetration resistance values shown in Fig. 14 are consistent with these conditions. A cross-section of the embankment showing all the modifications and ground improvement work through 1994 is shown in Fig. 15.

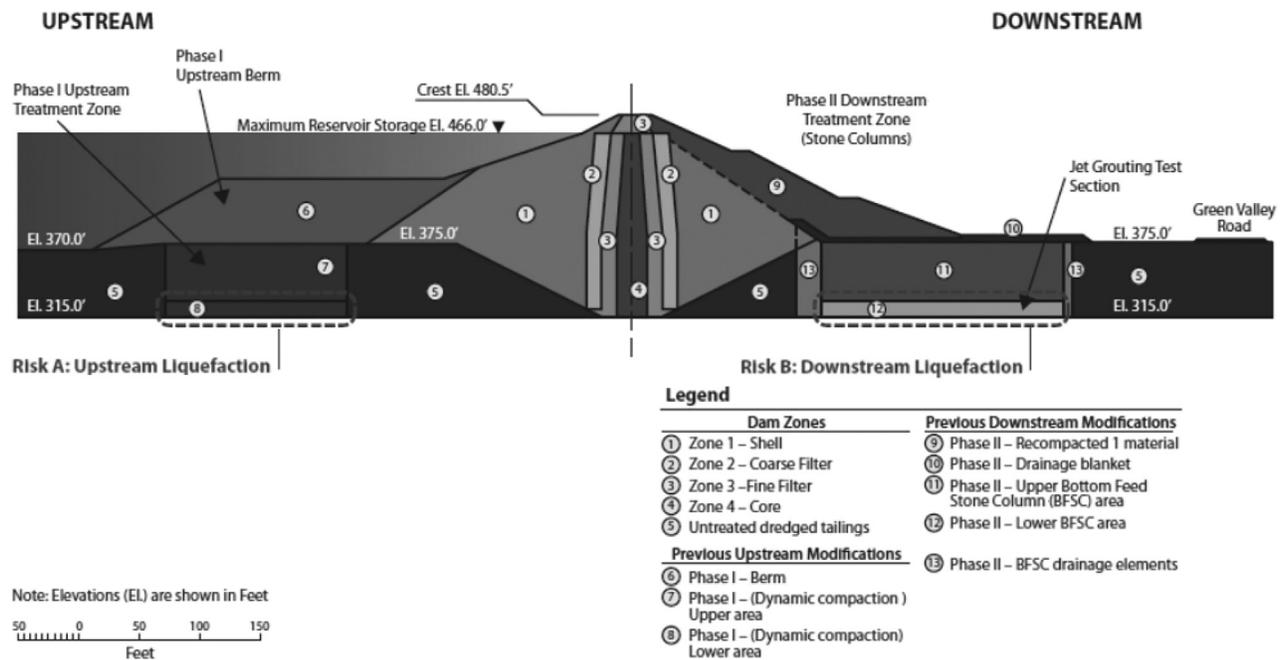
Figure 15 - Cross-section of Mormon Island Auxiliary Dam showing conditions after modifications completed in 1994 (adapted from U.S. Bureau of Reclamation, 2010).

The choice of the most appropriate ground improvement method or methods for mitigation of failure risks to dams is critical. In retrospect, the use of deep dynamic compaction for upstream foundation improvement at MIAD was later deemed not effective because of the unimproved zone that remained beneath the densified block, Fig. 10 and Zone 8 in Fig. 15. The presence of the high fines content in the lower portion of the downstream foundation soil at MIAD, Fig. 14 and Zone 12 in Fig. 15, was later deemed responsible for the stone columns to provide the improvement needed.

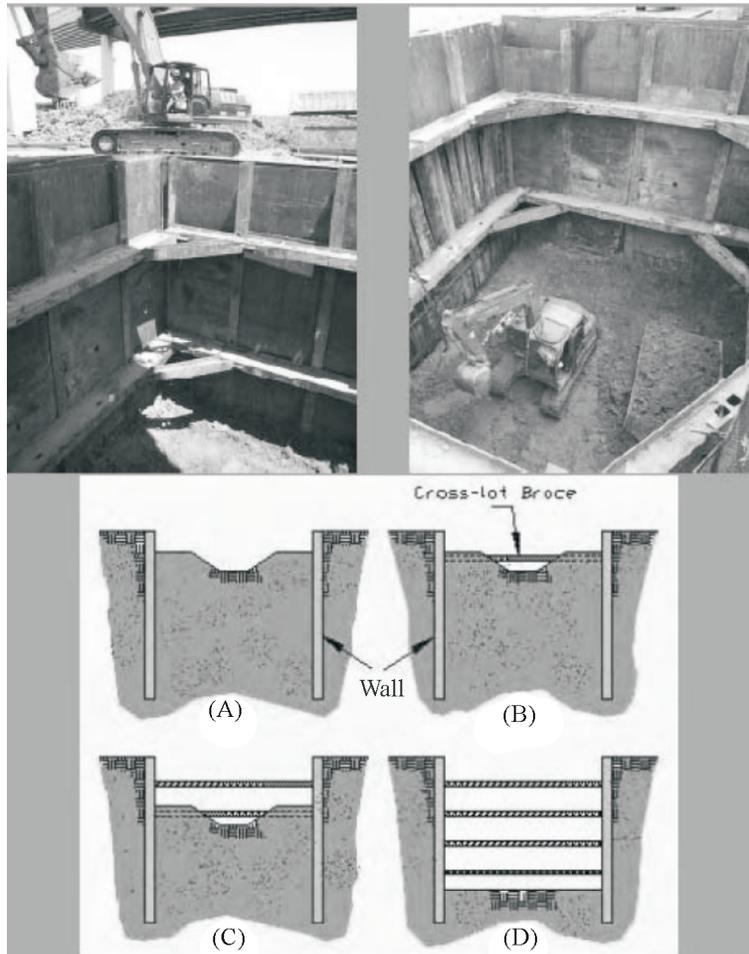
Figure 16 - Schematic diagram and photos of the excavation and bracing system for construction of the concrete key block in the downstream toe area of Mormon Island Auxiliary Dam (adapted from U.S. Bureau of Reclamation).

An additional point of interest is that jet grouting was proposed initially for construction of the key block. However, the results of an extensive test program indicated that the required continuity and strength of soilcrete could not be obtained owing to the presence of gravel, cobbles, and stone columns in the treatment zone. Jet grouting was ultimately judged to be technically and economically unfeasible for this purpose at this site. As a result, construction of the key block was accomplished within a series of contiguous cells, each being formed within an open, braced excavation. A photograph of this work in progress is shown in Fig. 16.

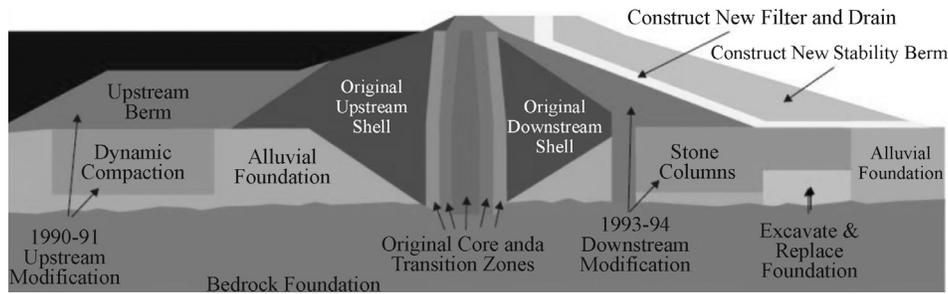
Figure 17 - Mormon Island Auxiliary Dam after completion (est. 2016) of modifications to assure seismic safety (adapted from U.S. Bureau of Reclamation).

The final configuration of MIAD will be as shown schematically in Fig. 17. The key block construction was completed in February 2013, and the buttress fill is scheduled for completion in 2016.
